General Information

Date & Time: 17, Feb, 2026 13:59

Make	Toyota	Model	Vios
YOM	2023	Odo Meter Reading	92,171
Registration No.	DBG6220	Chassis No.	PA1B18F37P4201214
CC	1.3	Transmission	CVT
Fuel Type	Gas	Type of Body	Sedan
Colour	Red Mica Metallic

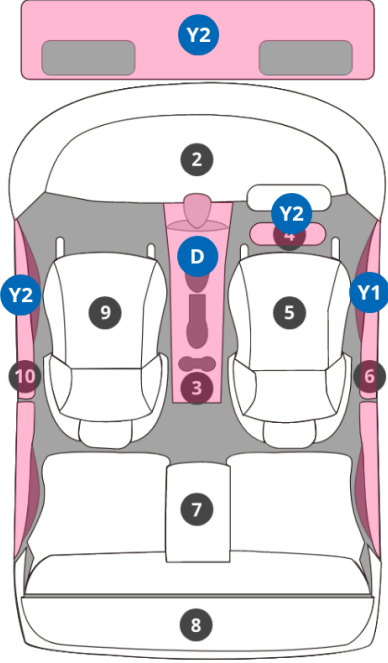
Interior Evaluation : B	Exterior Evaluation : E

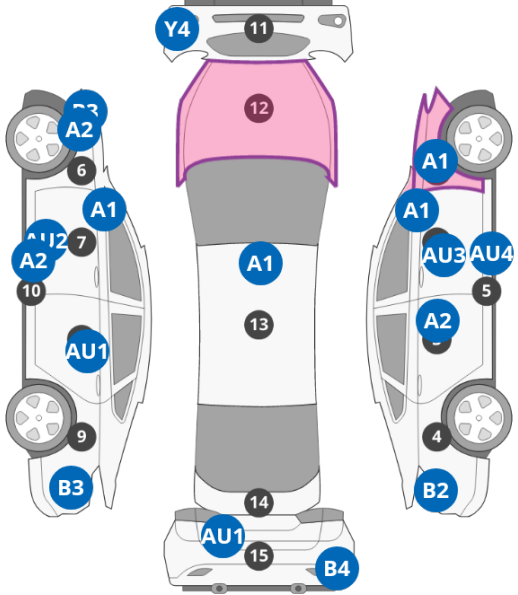
<p>A : Scratch AU : Scratch & Dent B : Modified C : Corrosion G : Stone chip P : Faded S : Rust SC : Rust & Corrosion U : Dent X : Defective Y : Crack, Gap</p>
<p>Remarks (L) Front Floor Mat - Grime - Small / Ceiling - Grime - Small / Console, Switchs, Vents - Traces of Adhesive Tape - Yes / (L) Front Trim - Grime - Small / (R) Front Trim - Grime - Minimal</p>	<p>Remarks (R) Front Fender - Repair Traces - Yes / Bonnet - Repair Traces - Yes / (L) Front Fender - Repair Traces - Yes / (R) Front Fender, Molding - Repair mark - Yes / (R) Front Fender, Molding - Scratch - Minimal / (R) Mirror - Scratch - Minimal / (R) Front Door, Molding - Scratch & Dent - Medium / (R) Step, In-panel, Side Spoiler - Scratch & Dent - Large / (R) Rear Door, Molding - Scratch - Small / (R) Rear Fender, Molding - Modified - Small / Rear Bumper, Lamps, Panels - Modified - Large / Trunk Hood, Rear Gate - Scratch & Dent - Minimal / (L) Rear Fender, Molding - Modified - Medium / (L) Rear Door, Molding - Scratch & Dent - Minimal / (L) Mirror - Scratch - Minimal / (L) Front Door, Molding - Scratch & Dent - Small / (L) Step, In-panel, Side Spoiler - Scratch - Small / Roof - Scratch - Minimal / Bonnet, Headlight - Repair mark - Difference in Color / (L) Front Fender, Molding - Modified - Medium / (L) Front Fender, Molding - Scratch - Small / Front Bumper, Grille, Lamps - Crack, Gap - Large</p>
