## General Information

<b>Make</b>	Toyota	<b>Model</b>	Vios
<b>YOM</b>	2026	<b>Odo Meter Reading</b>	10,843
<b>Registration No.</b>	CCQ4438	<b>Chassis No.</b>	PA1B18F31S4294241
<b>CC</b>	1.3	<b>Transmission</b>	CVT
<b>Fuel Type</b>	Gas	<b>Type of Body</b>	Sedan
<b>Colour</b>	Black

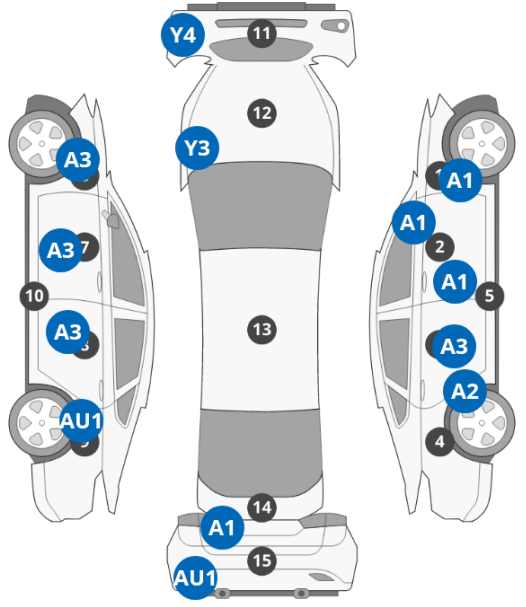
<p><b>A</b> : Scratch <b>AU</b> : Scratch &amp; Dent <b>B</b> : Modified <b>C</b> : Corrosion <b>G</b> : Stone chip <b>P</b> : Faded <b>S</b> : Rust <b>SC</b> : Rust &amp; Corrosion <b>U</b> : Dent <b>X</b> : Defective <b>Y</b> : Crack, Gap</p>
<b>Remarks</b> Defects not found	<b>Remarks</b> (R) Front Fender, Molding - Scratch - Minimal / (R) Mirror - Scratch - Minimal / (R) Front Door, Molding - Scratch - Minimal / (R) Rear Door, Molding - Scratch - Medium / (R) Rear Fender, Molding - Scratch - Small / Rear Bumper, Lamps, Panels - Scratch & Dent - Minimal / Trunk Hood, Rear Gate - Scratch - Minimal / (L) Rear Fender, Molding - Scratch & Dent - Minimal / (L) Rear Door, Molding - Scratch - Medium / (L) Front Door, Molding - Scratch - Medium / (L) Front Fender, Molding - Scratch - Medium / Front Bumper, Grille, Lamps - Crack, Gap - Large / Bonnet, Headlight - Crack, Gap - Medium

<b>Inspector Notes</b>
With Lto plate, with spare tire and jack, 1key, no warranty booklet and tools, scratches on headlights
