## General Information

| Make | Toyota | Model | Vios |
| Registration No. | NFI5649 | Chassis No. | PA1B18F36M4164720 |

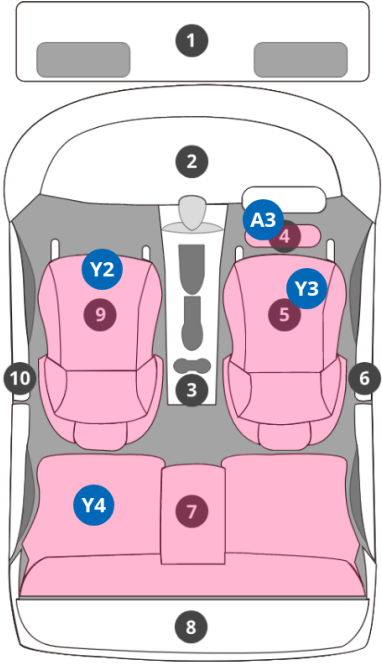
| Interior Evaluation : <span style="color: red;">C</span> | Exterior Evaluation : <span style="color: red;">B</span> |
|---|---|
| <b>Remarks</b><br>Rear Seat - Grime - Large / (L) Front Floor Mat - Cut, Crack - Medium / (L) Front Seat - Grime - Small / (R) Front Seat - Grime - Medium | <b>Remarks</b><br>Rear Bumper, Lamps, Panels - Scratch & Dent - Medium / (R) Step, In-panel, Side Spoiler - Scratch & Dent - Medium / Member (Bolted) - Dent - Yes / (L) Front Fender, Molding - Dent - Minimal / (R) Rear Door, Molding - Dent - Minimal / (R) Front Fender, Molding - Scratch - Small / Front Bumper, Grille, Lamps - Crack, Gap - Medium / Bonnet, Headlight - Dent - Small |
