## General Information

<b>Make</b>	Toyota	<b>Model</b>	Vios
<b>YOM</b>	2025	<b>Odo Meter Reading</b>	48,495
<b>Registration No.</b>	NKE3857	<b>Chassis No.</b>	PA1B132R4262893
<b>CC</b>	1.3	<b>Transmission</b>	CVT
<b>Fuel Type</b>	Gas	<b>Type of Body</b>	Sedan
<b>Colour</b>	Blue

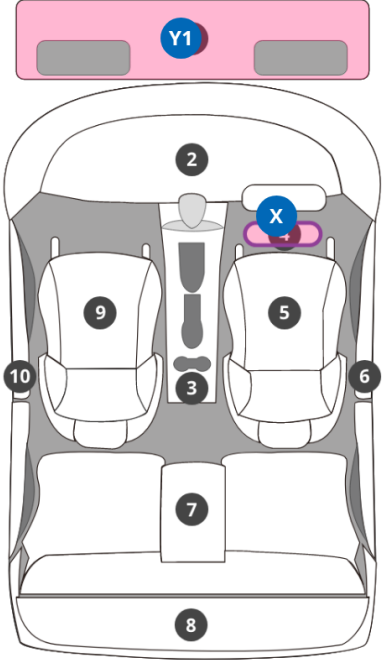
<b>Interior Evaluation :</b> <span style="float: right; color: red; font-weight: bold;">B</span>	<b>Exterior Evaluation :</b> <span style="float: right; color: red; font-weight: bold;">C</span>

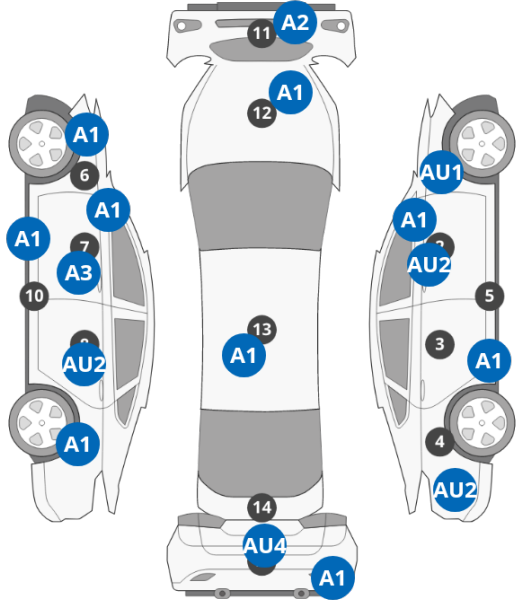
<p><b>A</b> : Scratch <b>AU</b> : Scratch &amp; Dent <b>B</b> : Modified <b>C</b> : Corrosion <b>G</b> : Stone chip <b>P</b> : Faded <b>S</b> : Rust <b>SC</b> : Rust &amp; Corrosion <b>U</b> : Dent <b>X</b> : Defective <b>Y</b> : Crack, Gap</p>
<b>Remarks</b> Ceiling - Grime - Minimal / Mat Other - Missing - Yes	<b>Remarks</b> (R) Rear Door - Repair Traces - Yes / (R) Front Fender, Molding - Scratch & Dent - Minimal / (R) Mirror - Scratch - Minimal / (R) Front Door, Molding - Scratch & Dent - Small / (R) Step, In-panel, Side Spoiler - Scratch - Minimal / (R) Rear Fender, Molding - Scratch & Dent - Small / Rear Bumper, Lamps, Panels - Scratch - Minimal / Trunk Hood, Rear Gate - Scratch & Dent - Large / (L) Rear Fender, Molding - Scratch - Minimal / (L) Rear Door, Molding - Scratch & Dent - Small / (L) Front Door, Molding - Scratch - Medium / (L) Mirror - Scratch - Minimal / (L) Step, In-panel, Side Spoiler - Scratch - Minimal / (L) Front Fender, Molding - Scratch - Minimal / Front Bumper, Grille, Lamps - Scratch - Small / Bonnet, Headlight - Scratch - Minimal / Roof - Scratch - Minimal

<b>Inspector Notes</b>
With Lto plate, with warranty booklet, with spare tire and jack, 2keys, no tools, fender light issue, scratches on headlights and taillights
