General Information

| Make | Toyota | Model | Vios |
| YOM | 2024 | Odo Meter Reading | 26,502 |
| Registration No. | CCD3006 | Chassis No. | PA1B18F3XR4252578 |

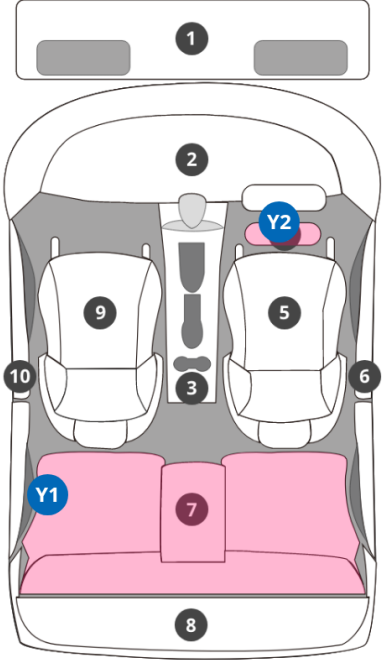
| Interior Evaluation : A | Exterior Evaluation : C |
| <p>Remarks Rear Seat - Grime - Minimal / (L) Front Floor Mat - Grime - Small</p> | <p>Remarks (R) Front Fender, Molding - Scratch - Minimal / (R) Mirror - Scratch - Minimal / (R) Front Door, Molding - Scratch - Minimal / (R) Step, In-panel, Side Spoiler - Scratch - Minimal / (R) Rear Door, Molding - Scratch - Minimal / (R) Rear Fender, Molding - Scratch - Minimal / Trunk Hood, Rear Gate - Scratch - Minimal / Rear Bumper, Lamps, Panels - Scratch - Medium / (L) Rear Fender, Molding - Scratch & Dent - Small / (L) Rear Door, Molding - Scratch & Dent - Minimal / (L) Front Door, Molding - Scratch & Dent - Small / Roof - Scratch - Minimal / (L) Front Fender, Molding - Scratch - Small / Front Bumper, Grille, Lamps - Scratch - Large / Bonnet, Headlight - Scratch - Minimal / Front Windshield - Damaged - Large / (L) Mirror - Scratch - Minimal</p> |

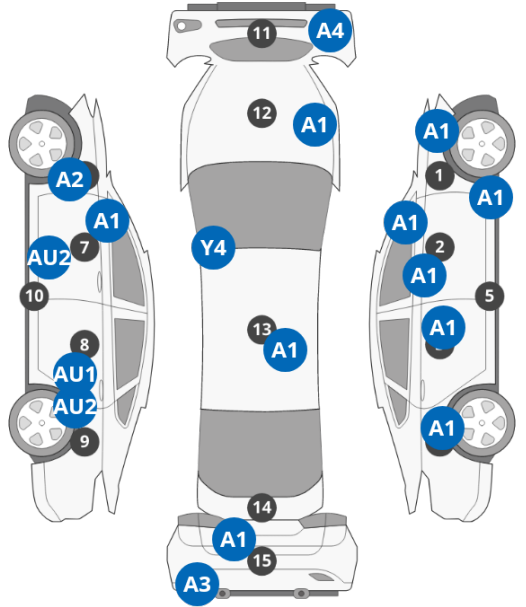
No front Lto plate,with warranty booklet, with spare tire and jack, 2keys, no tools ,dirt on engine ,scratches on headlights and taillights, battery weak, Crack windshield,
