General Information

Date & Time: 19, Feb, 2026 16:05

Make	Toyota	Model	Vios
YOM	2024	Odo Meter Reading	21,600
Registration No.	NHR6270	Chassis No.	PA1B18F36P4231157
CC	1.3	Transmission	CVT
Fuel Type	Gas	Type of Body	Sedan
Colour	Blue

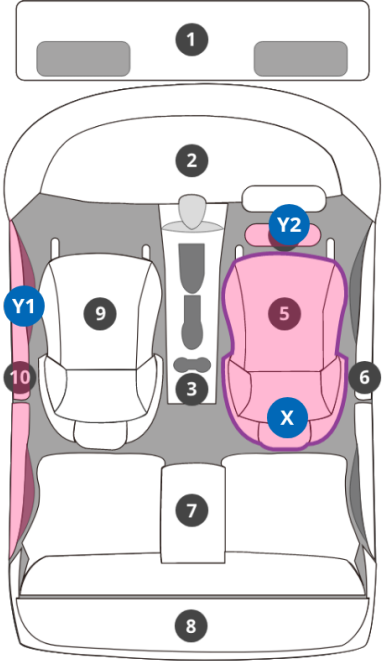
Interior Evaluation : B	Exterior Evaluation : C

<p>a : Cut, Fray d : Loose, Deformed k : Animal Hair s : Smell t : Cigarette Burns x : Defective y : Stain</p>

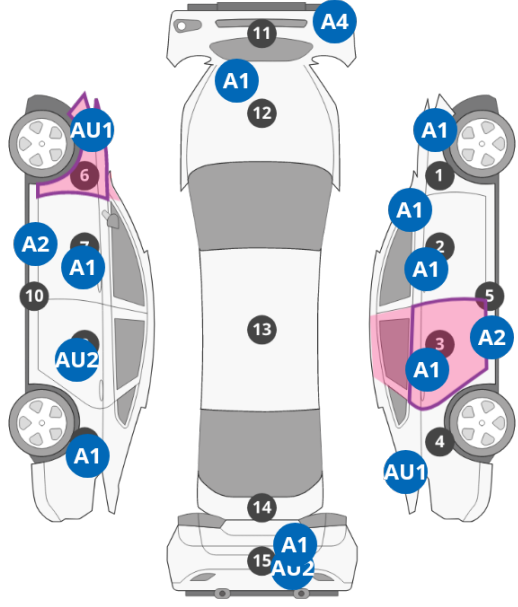
<p>A : Scratch AU : Scratch & Dent B : Modified C : Corrosion G : Stone chip P : Faded S : Rust SC : Rust & Corrosion U : Dent X : Defective Y : Crack, Gap</p>
<p>Remarks (L) Front Trim - Grime - Minimal / (L) Front Floor Mat - Grime - Small / (R) Front Seat Head Rest - Missing - Yes</p>	<p>Remarks (R) Front Door - Repair Traces - Yes / (R) Front Fender - Repair Traces - Yes / Bonnet - Repair Traces - Yes / (L) Front Fender - Repair Traces - Yes / (L) Front Door - Repair Traces - Yes / (L) Rear Door - Repair Traces - Yes / (L) Rear Fender - Repair Traces - Yes / (R) Rear Door - Repair Traces - Yes / (R) Rear Fender - Repair Traces - Yes / (R) Front Fender, Molding - Scratch - Minimal / (R) Mirror - Scratch - Minimal / (R) Front Door, Molding - Scratch - Minimal / Overall Exterior - Full Re-Paint in same color - Yes / (R) Rear Door, Molding - Scratch - Minimal / (R) Rear Door, Molding - Repair mark - Yes / (R) Rear Fender, Molding - Scratch & Dent - Minimal / (R) Step, In-panel, Side Spoiler - Scratch - Small / Rear Bumper, Lamps, Panels - Scratch & Dent - Small / Trunk Hood, Rear Gate - Scratch - Minimal / (L) Rear Fender, Molding - Scratch - Minimal / (L) Rear Door, Molding - Scratch & Dent - Small / (L) Step, In-panel, Side Spoiler - Scratch - Small / (L) Front Door, Molding - Scratch - Minimal / (L) Front Fender, Molding - Repair mark - Yes / (L) Front Fender, Molding - Scratch & Dent - Minimal / Front Bumper, Grille, Lamps - Scratch - Large / Bonnet, Headlight - Scratch - Minimal</p>
