## General Information

<b>Make</b>	Toyota	<b>Model</b>	Vios
<b>YOM</b>	2024	<b>Odo Meter Reading</b>	18,908
<b>Registration No.</b>	CCA8777	<b>Chassis No.</b>	PA1B18F39R4258341
<b>CC</b>	1.3	<b>Transmission</b>	CVT
<b>Fuel Type</b>	Gas	<b>Type of Body</b>	Sedan
<b>Colour</b>	Blackish Red Mica

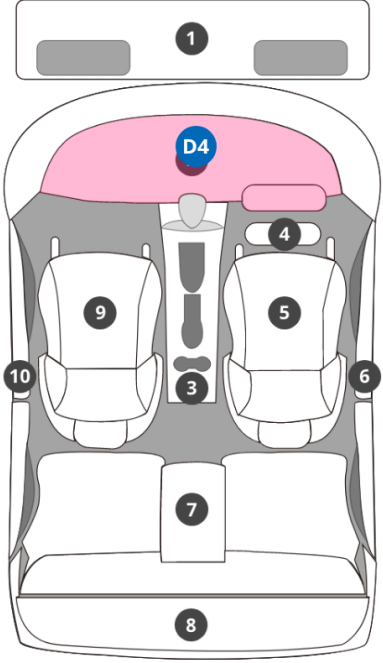
<b>Interior Evaluation :</b> <span style="float: right; color: red; font-weight: bold;">C</span>	<b>Exterior Evaluation :</b> <span style="float: right; color: red; font-weight: bold;">D</span>

<p><b>A</b> : Scratch <b>AU</b> : Scratch &amp; Dent <b>B</b> : Modified <b>C</b> : Corrosion <b>G</b> : Stone chip <b>P</b> : Faded <b>S</b> : Rust <b>SC</b> : Rust &amp; Corrosion <b>U</b> : Dent <b>X</b> : Defective <b>Y</b> : Crack, Gap</p>
<b>Remarks</b> Dashboard - Loose, Deformed - Large	<b>Remarks</b> (R) Front Fender, Molding - Scratch - Small / (R) Mirror - Scratch - Minimal / (R) Front Door, Molding - Scratch - Large / (R) Step, In-panel, Side Spoiler - Scratch - Minimal / (R) Rear Door, Molding - Scratch - Minimal / Roof - Dent - Minimal / (R) Rear Fender, Molding - Scratch - Minimal / Trunk Hood, Rear Gate - Scratch - Minimal / Rear Bumper, Lamps, Panels - Scratch - Small / (L) Rear Fender, Molding - Scratch - Minimal / (L) Rear Door, Molding - Scratch - Small / (L) Step, In-panel, Side Spoiler - Scratch - Medium / (L) Front Door, Molding - Scratch & Dent - Large / (L) Front Fender, Molding - Scratch & Dent - Medium / (L) Mirror - Scratch - Minimal / Bonnet, Headlight - Scratch - Minimal / Front Bumper, Grille, Lamps - Scratch - Minimal
