## General Information

<b>Make</b>	Toyota	<b>Model</b>	Vios
<b>YOM</b>	2025	<b>Odo Meter Reading</b>	6,471
<b>Registration No.</b>	NJA5461	<b>Chassis No.</b>	PA1B18F35S4283727
<b>CC</b>	1.3	<b>Transmission</b>	CVT
<b>Fuel Type</b>	Gas	<b>Type of Body</b>	Sedan
<b>Colour</b>	Blue

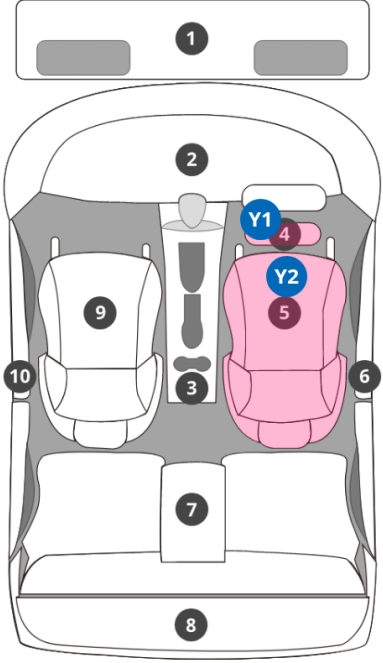
<b>Interior Evaluation :</b> <span style="color: red; font-size: 1.5em; float: right;">A</span>	<b>Exterior Evaluation :</b> <span style="color: red; font-size: 1.5em; float: right;">C</span>

<p><b>A</b> : Scratch <b>AU</b> : Scratch &amp; Dent <b>B</b> : Modified <b>C</b> : Corrosion <b>G</b> : Stone chip <b>P</b> : Faded <b>S</b> : Rust <b>SC</b> : Rust &amp; Corrosion <b>U</b> : Dent <b>X</b> : Defective <b>Y</b> : Crack, Gap</p>
<p><b>Remarks</b> (R) Front Seat - Grime - Small / (L) Front Floor Mat - Grime - Minimal</p>	<p><b>Remarks</b> (R) Front Fender, Molding - Scratch - Minimal / Roof - Scratch - Minimal / (R) Front Door, Molding - Scratch - Minimal / (R) Rear Door, Molding - Scratch - Minimal / Rear Bumper, Lamps, Panels - Scratch - Small / Trunk Hood, Rear Gate - Scratch - Minimal / (L) Rear Fender, Molding - Scratch - Minimal / (L) Front Door, Molding - Scratch - Minimal / (L) Rear Door, Molding - Scratch - Minimal / (L) Mirror - Scratch - Minimal / (L) Step, In-panel, Side Spoiler - Scratch - Minimal / (L) Front Fender, Molding - Scratch - Minimal / Front Bumper, Grille, Lamps - Scratch - Large / Bonnet, Headlight - Scratch - Small</p>
