## General Information

Date & Time: 18, Feb, 2026 16:08

<b>Make</b>	Toyota	<b>Model</b>	Wigo
<b>YOM</b>	2024	<b>Odo Meter Reading</b>	22,111
<b>Registration No.</b>	DBQ2900	<b>Chassis No.</b>	MHKAA1BCXRJ024270
<b>CC</b>	1.0	<b>Transmission</b>	CVT
<b>Fuel Type</b>	Gas	<b>Type of Body</b>	Hatchback
<b>Colour</b>	Gray

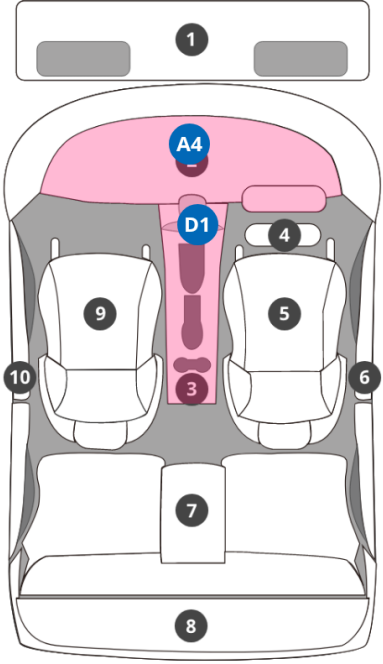
<b>Interior Evaluation :</b> <span style="color: red; font-size: 1.5em; vertical-align: middle;">C</span>	<b>Exterior Evaluation :</b> <span style="color: red; font-size: 1.5em; vertical-align: middle;">B</span>

<p><b>a</b> : Cut, Fray <b>d</b> : Loose, Deformed <b>k</b> : Animal Hair <b>s</b> : Smell <b>t</b> : Cigarette Burns <b>x</b> : Defective <b>y</b> : Stain</p>

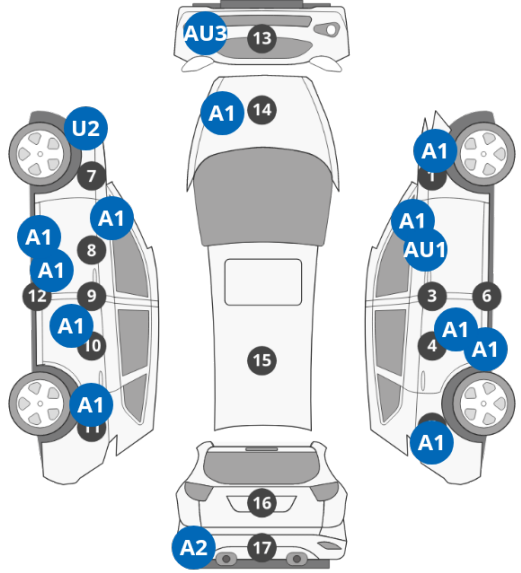
<p><b>A</b> : Scratch <b>AU</b> : Scratch &amp; Dent <b>B</b> : Modified <b>C</b> : Corrosion <b>G</b> : Stone chip <b>P</b> : Faded <b>S</b> : Rust <b>SC</b> : Rust &amp; Corrosion <b>U</b> : Dent <b>X</b> : Defective <b>Y</b> : Crack, Gap</p>
<p><b>Remarks</b> Steering Wheel - Worn, Peel, Crack - Large / Console, Switches, Vents - Loose, Deformed - Minimal</p>	<p><b>Remarks</b> (R) Front Fender, Molding - Scratch - Minimal / (R) Mirror - Scratch - Minimal / (R) Front Door, Molding - Scratch &amp; Dent - Minimal / (R) Step, In-panel, Side Spoiler - Scratch - Minimal / (R) Rear Fender, Molding - Scratch - Minimal / (R) Rear Door, Molding - Scratch - Minimal / Rear Bumper, Lamps, Panels - Scratch - Small / (L) Rear Fender, Molding - Scratch - Minimal / (L) Rear Door, Molding - Scratch - Minimal / (L) Mirror - Scratch - Minimal / (L) Front Door, Molding - Scratch - Minimal / (L) Step, In-panel, Side Spoiler - Scratch - Minimal / (L) Front Fender, Molding - Dent - Small / Front Bumper, Grille, Lamps - Scratch &amp; Dent - Medium / Bonnet, Headlight - Scratch - Minimal</p>
