## General Information

<b>Make</b>	Toyota	<b>Model</b>	Vios
<b>YOM</b>	2022	<b>Odo Meter Reading</b>	76,125
<b>Registration No.</b>	CBK5724-1	<b>Chassis No.</b>	PA1B1F32N4175943
<b>CC</b>	1.3	<b>Transmission</b>	CVT
<b>Fuel Type</b>	Gas	<b>Type of Body</b>	Sedan
<b>Colour</b>	Blackish Red Mica

## Body / Panel Condition

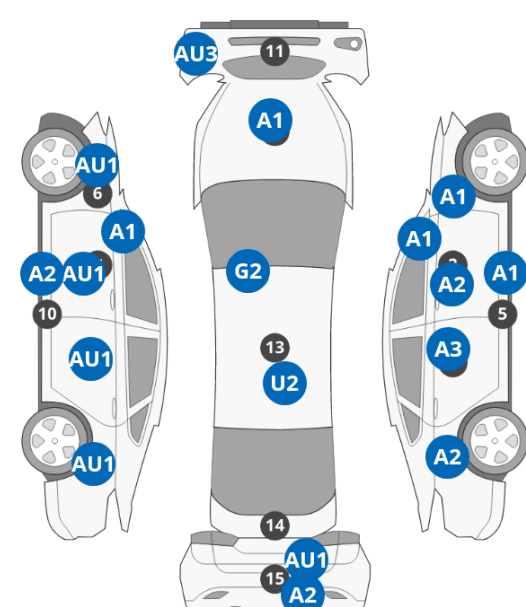
<p><b>A</b> : Scratch <b>AU</b> : Scratch &amp; Dent <b>B</b> : Modified <b>C</b> : Corrosion <b>G</b> : Stone chip <b>P</b> : Faded <b>S</b> : Rust <b>SC</b> : Rust &amp; Corrosion <b>U</b> : Dent <b>X</b> : Defective <b>Y</b> : Crack, Gap</p>
<p><b>Remarks</b> Trunk Room - Loose, Deformed - Medium / (L) Front Trim - Grime - Small / (L) Front Seat - Grime - Minimal</p>	<p><b>Remarks</b> (R) Front Fender, Molding - Scratch - Minimal / (R) Mirror - Scratch - Minimal / (R) Front Door, Molding - Scratch - Small / (R) Rear Door, Molding - Scratch - Medium / (R) Rear Fender, Molding - Scratch - Small / Rear Bumper, Lamps, Panels - Scratch - Small / Trunk Hood, Rear Gate - Scratch &amp; Dent - Minimal / (L) Rear Fender, Molding - Scratch &amp; Dent - Minimal / (L) Rear Door, Molding - Scratch &amp; Dent - Minimal / (L) Front Door, Molding - Scratch &amp; Dent - Minimal / (L) Mirror - Scratch - Minimal / (L) Front Fender, Molding - Scratch &amp; Dent - Minimal / Roof - Dent - Small / Front Windshield - Scratch, Stone chip - Small / Bonnet, Headlight - Scratch - Minimal / Front Bumper, Grille, Lamps - Scratch &amp; Dent - Medium / (R) Step, In-panel, Side Spoiler - Scratch - Minimal / (L) Step, In-panel, Side Spoiler - Scratch - Small</p>
