## General Information

| <b>Make</b> | Toyota | <b>Model</b> | Avanza |
| <b>Registration No.</b> | GBF9224 | <b>Chassis No.</b> | MHFAB1BY2R3115030 |

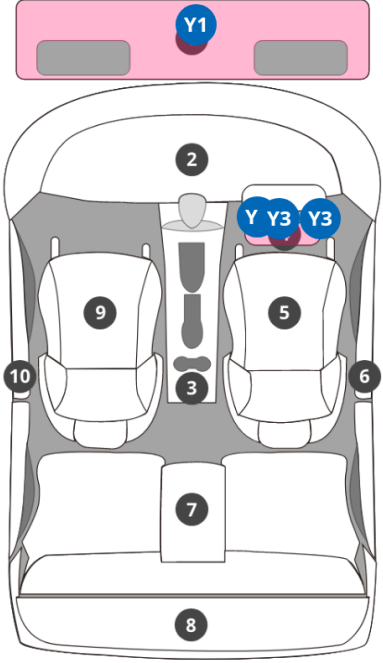
| <b>Interior Evaluation :</b> <span style="float: right; color: red; font-weight: bold;">B</span> | <b>Exterior Evaluation :</b> <span style="float: right; color: red; font-weight: bold;">C</span> |
| <p><b>Remarks</b><br/>(L) Front Floor Mat - Grime - Minimal / Ceiling - Grime - Minimal / Mat Other - Grime - Medium / (R) Front Floor Mat - Grime - Medium</p> | <p><b>Remarks</b><br/>(R) Front Door - Repair Traces - Yes / (R) Step - Repair Traces - Yes / (R) Rear Fender - Repair Traces - Yes / (R) Rear Door - Repair Traces - Yes / (L) Step, In-panel, Side Spoiler - Scratch - Minimal / (L) Rear Door, Molding - Scratch - Small / (L) Front Door, Molding - Scratch - Small / Rear Bumper, Lamps, Panels - Scratch - Large / (R) Rear Fender, Molding - Scratch - Small / (R) Step, In-panel, Side Spoiler - Scratch - Small / (R) Mirror - Scratch - Small / Bonnet, Headlight - Scratch - Small / Front Bumper, Grille, Lamps - Scratch - Small / Roof - Scratch &amp; Dent - Minimal</p> |

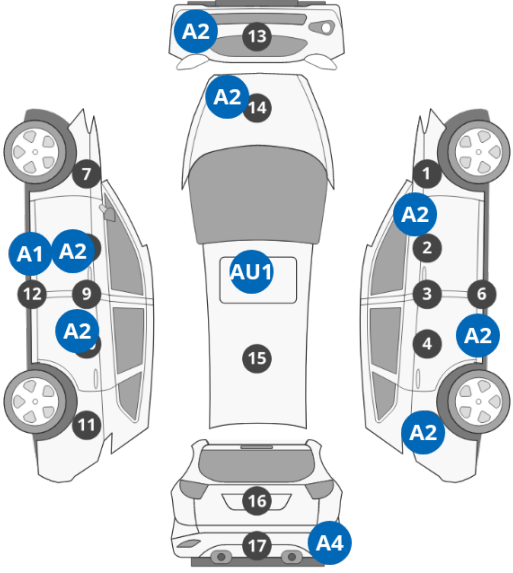
| <p>Right front and rear door and right rear fender repainted. Gap at front bumper. Retractable and power folding side mirror not working. With warranty booklet, spare tire, jack and seat cover. Without tools. 2 keys. With LTO plate.</p> |
