## General Information

<b>Make</b>	Toyota	<b>Model</b>	Vios
<b>YOM</b>	2024	<b>Odo Meter Reading</b>	20,112
<b>Registration No.</b>	GBA5775	<b>Chassis No.</b>	PA1B18F39P4228530
<b>CC</b>	1.3	<b>Transmission</b>	CVT
<b>Fuel Type</b>	Gas	<b>Type of Body</b>	Sedan
<b>Colour</b>	Silver

## Body / Panel Condition

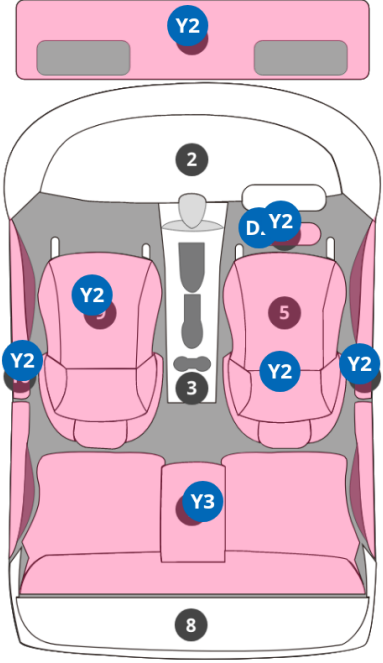
<b>Interior Evaluation :</b> <span style="float: right;"><b>B</b></span>	<b>Exterior Evaluation :</b> <span style="float: right;"><b>C</b></span>

<p><b>a</b> : Cut, Fray <b>d</b> : Loose, Deformed <b>k</b> : Animal Hair <b>s</b> : Smell <b>t</b> : Cigarette Burns <b>x</b> : Defective <b>y</b> : Stain</p>

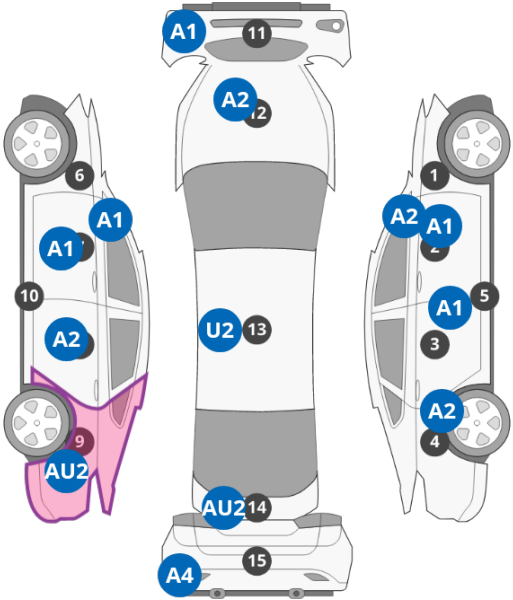
<p><b>A</b> : Scratch <b>AU</b> : Scratch &amp; Dent <b>B</b> : Modified <b>C</b> : Corrosion <b>G</b> : Stone chip <b>P</b> : Faded <b>S</b> : Rust <b>SC</b> : Rust &amp; Corrosion <b>U</b> : Dent <b>X</b> : Defective <b>Y</b> : Crack, Gap</p>
<p><b>Remarks</b> (L) Front Trim - Grime - Small / (L) Front Floor Mat - Worked - Small / (L) Front Seat - Grime - Small / Ceiling - Grime - Small / Mat Other - Grime - Small / Rear Seat - Grime - Medium / (R) Front Trim - Grime - Small / (R) Front Seat - Grime - Small</p>	<p><b>Remarks</b> (L) Step - Repair Traces - Yes / (L) Rear Fender - Repair Traces - Yes / (L) Mirror - Scratch - Minimal / (L) Front Door, Molding - Scratch - Minimal / (L) Rear Door, Molding - Scratch - Small / (L) Rear Fender, Molding - Repair mark - Yes / (L) Rear Fender, Molding - Scratch &amp; Dent - Small / Trunk Hood, Rear Gate - Scratch &amp; Dent - Small / (R) Rear Fender, Molding - Scratch - Small / Rear Bumper, Lamps, Panels - Scratch - Large / (R) Rear Door, Molding - Scratch - Minimal / (R) Mirror - Scratch - Small / (R) Front Door, Molding - Scratch - Minimal / Front Bumper, Grille, Lamps - Scratch - Minimal / Bonnet, Headlight - Scratch - Small / Roof - Dent - Small</p>
