## General Information

<b>Make</b>	Toyota	<b>Model</b>	Hilux Tamaraw
<b>YOM</b>	2025	<b>Odo Meter Reading</b>	12,421
<b>Registration No.</b>	NJF5205	<b>Chassis No.</b>	PAHACACA6S6422642
<b>CC</b>	2.4	<b>Transmission</b>	M/T
<b>Fuel Type</b>	Diesel	<b>Type of Body</b>	Utility Passenger
<b>Colour</b>	White

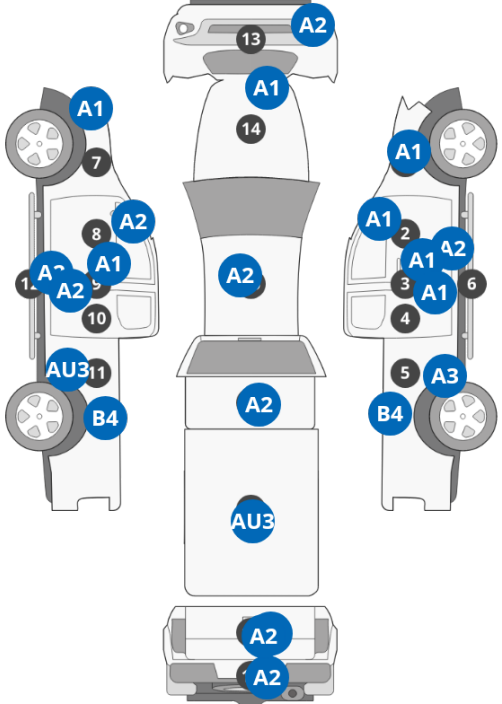
<p><b>A</b> : Scratch <b>AU</b> : Scratch &amp; Dent <b>B</b> : Modified <b>C</b> : Corrosion <b>G</b> : Stone chip <b>P</b> : Faded <b>S</b> : Rust <b>SC</b> : Rust &amp; Corrosion <b>U</b> : Dent <b>X</b> : Defective <b>Y</b> : Crack, Gap</p>
<p><b>Remarks</b> (L) Front Floor Mat - Worked - Small / (R) Front Floor Mat - Worked - Small / (R) Front Seat - Grime - Small / (L) Front Seat - Grime - Small / (R) Front Trim - Worked - Small</p>	<p><b>Remarks</b> (R) Front Fender, Molding - Scratch - Minimal / (R) Mirror - Scratch - Minimal / (R) Step, In-panel, Side Spoiler - Scratch - Small / (R) Front Door, Molding - Scratch - Minimal / (R) Center Panel - Scratch - Minimal / (R) Side Gate - Scratch - Medium / Rear Bumper, Lamps, Panels - Scratch - Small / Rear Gate - Modified - Small / Rear Gate - Scratch - Small / (L) Side Gate - Scratch &amp; Dent - Medium / (L) Step, In-panel, Side Spoiler - Scratch - Small / (L) Center Panel - Scratch - Small / (L) Front Door, Molding - Scratch - Minimal / (L) Mirror - Scratch - Small / (L) Front Fender, Molding - Scratch - Minimal / Front Bumper, Grille, Lamps - Scratch - Small / Bonnet, Headlight - Scratch - Minimal / Roof - Scratch - Small / Cab Back Panel - Scratch - Small / Cargo Bed Floor - Scratch &amp; Dent - Medium / (R) Side Gate - Modified - Large / (L) Side Gate - Modified - Large</p>
