## General Information

Date & Time: 21, Feb, 2026 13:25

Make	Mazda	Model	Mazda 2
YOM	2018	Odo Meter Reading	64,746
Registration No.	NCA9981	Chassis No.	MM7DL28AAJW317367
CC	1.5	Transmission	A/T
Fuel Type	Gas	Type of Body	Sedan
Colour	Silver

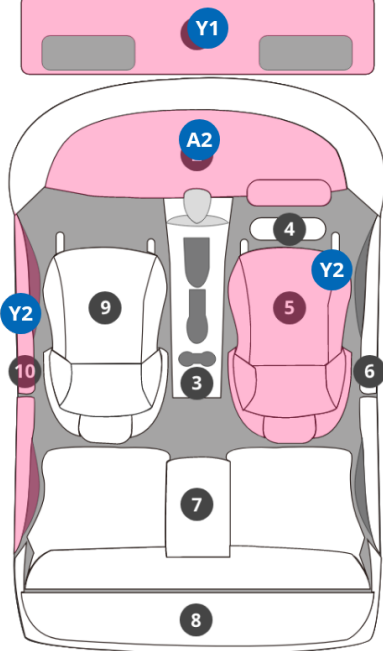
<b>Interior Evaluation :</b> <span style="float: right; color: red; font-weight: bold;">A</span>	<b>Exterior Evaluation :</b> <span style="float: right; color: red; font-weight: bold;">C</span>

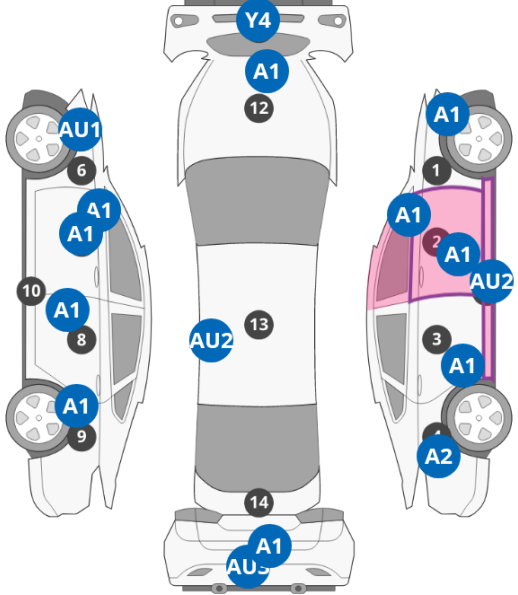
<p><b>A</b> : Scratch <b>AU</b> : Scratch &amp; Dent <b>B</b> : Modified <b>C</b> : Corrosion <b>G</b> : Stone chip <b>P</b> : Faded <b>S</b> : Rust <b>SC</b> : Rust &amp; Corrosion <b>U</b> : Dent <b>X</b> : Defective <b>Y</b> : Crack, Gap</p>
<p><b>Remarks</b> (L) Front Trim - Grime - Small / Steering Wheel - Worn, Peel, Crack - Small / Ceiling - Grime - Minimal / (R) Front Seat - Grime - Small</p>	<p><b>Remarks</b> (R) Front Fender, Molding - Scratch - Minimal / (R) Mirror - Scratch - Minimal / (R) Front Door, Molding - Repair mark - Yes / (R) Front Door, Molding - Scratch - Minimal / (R) Rear Door, Molding - Scratch - Minimal / (R) Rear Fender, Molding - Scratch - Small / Rear Bumper, Lamps, Panels - Scratch &amp; Dent - Medium / Trunk Hood, Rear Gate - Scratch - Minimal / (L) Rear Fender, Molding - Scratch - Minimal / Roof - Scratch &amp; Dent - Small / (L) Rear Door, Molding - Scratch - Minimal / (R) Step, In-panel, Side Spoiler - Repair mark - Yes / (R) Step, In-panel, Side Spoiler - Scratch &amp; Dent - Small / (L) Mirror - Scratch - Minimal / (L) Front Door, Molding - Scratch - Minimal / (L) Front Fender, Molding - Scratch &amp; Dent - Minimal / Front Bumper, Grille, Lamps - Crack, Gap - Large / Bonnet, Headlight - Scratch - Minimal</p>
