## General Information

| <b>Make</b> | Toyota | <b>Model</b> | Vios |

## Body / Panel Condition

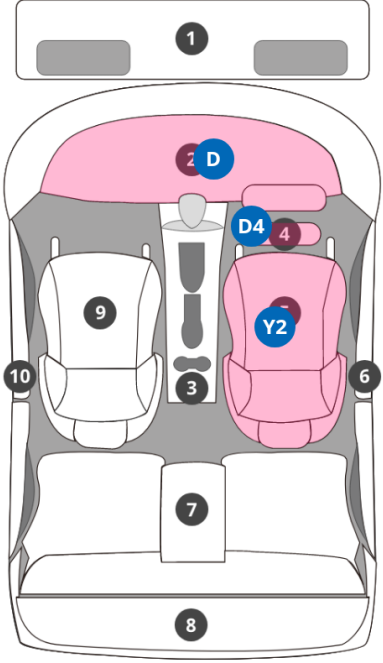
| <b>Interior Evaluation :</b> <span style="float: right; color: red; font-weight: bold;">C</span> | <b>Exterior Evaluation :</b> <span style="float: right; color: red; font-weight: bold;">E</span> |

| <p><b>Remarks</b><br/>(R) Front Seat - Grime - Small / Dashboard - Traces of Adhesive Tape - Yes / (L) Front Floor Mat - Worked - Large</p> | <p><b>Remarks</b><br/>(R) Front Door - Repair Traces - Yes / (R) Step - Repair Traces - Yes / (L) Front Door - Repair Traces - Yes / (L) Step - Repair Traces - Yes / (L) Rear Door - Repair Traces - Yes / (L) Rear Fender - Repair Traces - Yes / Trunk Hood, Rear Gate - Repair Traces - Yes / (R) Rear Fender - Repair Traces - Yes / (L) Rear Door, Molding - Scratch - Large / (L) Front Door, Molding - Scratch - Large / (L) Front Fender, Molding - Crack, Gap - Medium / Bonnet, Headlight - Rust, Corrosion - Medium / Front Bumper, Grille, Lamps - Scratch - Large / (R) Front Door, Molding - Scratch - Medium / (R) Rear Door, Molding - Scratch - Small / Trunk Hood, Rear Gate - Scratch - Medium / Rear Bumper, Lamps, Panels - Scratch &amp; Dent - Medium / (L) Rear Fender, Molding - Scratch - Small / (R) Rear Fender, Molding - Scratch - Small / (R) Front Fender, Molding - Scratch &amp; Dent - Small</p> |
