General Information

Make	Hyundai	Model	Accent
YOM	2018	Odo Meter Reading	77,627
Registration No.	EAB2450	Chassis No.	KMHC41UAJU403425
CC	1.6	Transmission	A/T
Fuel Type	Gas	Type of Body	Sedan
Colour	Red

Body / Panel Condition

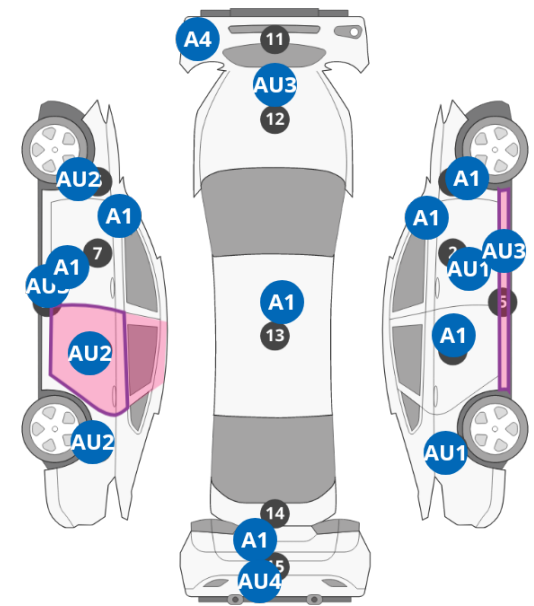
<p>A : Scratch AU : Scratch & Dent B : Modified C : Corrosion G : Stone chip P : Faded S : Rust SC : Rust & Corrosion U : Dent X : Defective Y : Crack, Gap</p>
<p>Remarks Ceiling - Loose, Deformed - Medium / (R) Rear Trim - Grime - Small / (R) Front Trim - Grime - Medium / (L) Rear Trim - Grime - Small / (L) Front Trim - Grime - Medium / (L) Front Seat - Grime - Small / Steering Wheel - Worn, Peel, Crack - Medium</p>	<p>Remarks (R) Step - Repair Traces - Yes / (L) Step - Repair Traces - Yes / (R) Front Fender, Molding - Scratch - Minimal / (R) Mirror - Scratch - Minimal / (R) Front Door, Molding - Scratch & Dent - Minimal / (R) Step, In-panel, Side Spoiler - Scratch & Dent - Medium / (R) Step, In-panel, Side Spoiler - Repair mark - Yes / (R) Rear Door, Molding - Scratch - Minimal / (R) Rear Fender, Molding - Scratch & Dent - Minimal / Trunk Hood, Rear Gate - Scratch - Minimal / Rear Bumper, Lamps, Panels - Scratch & Dent - Large / (L) Rear Fender, Molding - Scratch & Dent - Small / (L) Rear Door, Molding - Scratch & Dent - Small / (L) Rear Door, Molding - Repair mark - Yes / (L) Mirror - Scratch, Peeled - Minimal / (L) Step, In-panel, Side Spoiler - Scratch & Dent - Medium / (L) Front Door, Molding - Scratch - Minimal / (L) Front Fender, Molding - Scratch & Dent - Small / Bonnet, Headlight - Scratch & Dent - Medium / Front Bumper, Grille, Lamps - Scratch - Large / Roof - Scratch - Minimal</p>
