General Information

Make	Mitsubishi	Model	Xpander
YOM	2023	Odo Meter Reading	29,363
Registration No.	NIG6439	Chassis No.	MK2LRNC1WPN009413
CC	1.5	Transmission	CVT
Fuel Type	Gas	Type of Body	Wagon
Colour	Black

Body / Panel Condition

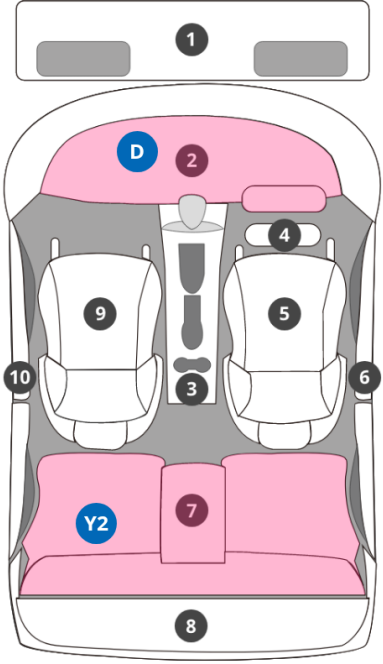
Interior Evaluation : C	Exterior Evaluation : E

<p>A : Scratch AU : Scratch & Dent B : Modified C : Corrosion G : Stone chip P : Faded S : Rust SC : Rust & Corrosion U : Dent X : Defective Y : Crack, Gap</p>
<p>Remarks Overall Interior - Worn as per age - Yes / Rear Seat - Grime - Small / Dashboard - Traces of Adhesive Tape - Yes</p>	<p>Remarks Front Bumper, Grille, Lamps - Scratch - Large / (L) Front Door, Molding - Dent - Small / (L) Step, In-panel, Side Spoiler - Scratch & Dent - Small / (L) Rear Door, Molding - Scratch - Medium / (L) Rear Fender, Molding - Repair mark - Yes / (L) Rear Fender, Molding - Scratch & Dent - Medium / Trunk Hood, Rear Gate - Repair mark - Yes / Rear Bumper, Lamps, Panels - Scratch - Large / (R) Front Door, Molding - Scratch & Dent - Large / (R) Rear Fender, Molding - Scratch - Medium / (R) Rear Door, Molding - Scratch - Large / (R) Front Fender, Molding - Scratch - Large / (R) Step, In-panel, Side Spoiler - Scratch & Dent - Small / Roof - Dent - Medium / Bonnet, Headlight - Scratch - Small</p>
