General Information

Make	Mitsubishi	Model	Xpander
YOM	2019	Odo Meter Reading	71,839
Registration No.	DAL2857	Chassis No.	MK2XRNC1WKN022486
CC	1.5	Transmission	A/T
Fuel Type	Gas	Type of Body	Wagon
Colour	Red Mica Metallic

Body / Panel Condition

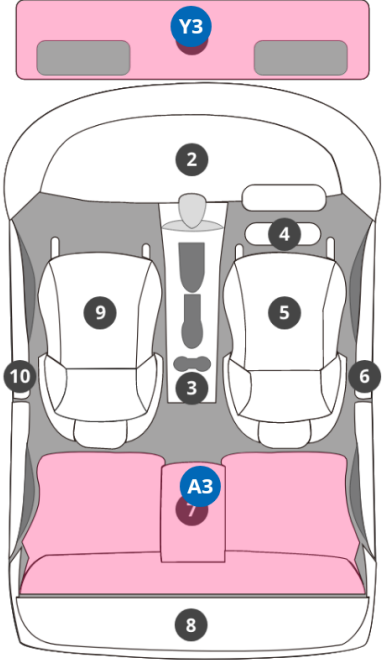
Interior Evaluation : B	Exterior Evaluation : C

<p>a : Cut, Fray d : Loose, Deformed k : Animal Hair s : Smell t : Cigarette Burns x : Defective y : Stain</p>

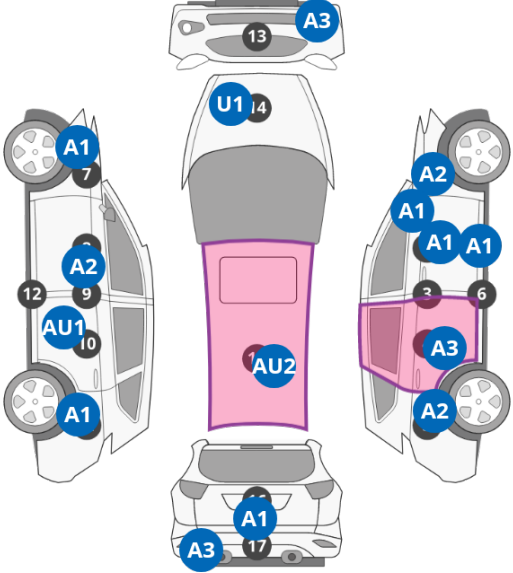
<p>A : Scratch AU : Scratch & Dent B : Modified C : Corrosion G : Stone chip P : Faded S : Rust SC : Rust & Corrosion U : Dent X : Defective Y : Crack, Gap</p>
Remarks Ceiling - Grime - Medium / Rear Seat - Cut, Crack - Medium	Remarks Trunk Hood, Rear Gate - Repair Traces - Yes / (R) Rear Fender - Repair Traces - Yes / (R) Front Fender, Molding - Scratch - Small / (R) Mirror - Scratch - Minimal / (R) Front Door, Molding - Scratch - Minimal / (R) Step, In-panel, Side Spoiler - Scratch - Minimal / (R) Rear Door, Molding - Repair mark - Yes / (R) Rear Door, Molding - Scratch - Medium / (R) Rear Fender, Molding - Scratch - Small / Roof - Scratch & Dent - Small / Roof Spoiler, Molding - Repair mark - Yes / Trunk Hood, Rear Gate - Scratch - Minimal / Rear Bumper, Lamps, Panels - Scratch - Medium / (L) Rear Fender, Molding - Scratch - Minimal / (L) Rear Door, Molding - Scratch & Dent - Minimal / (L) Front Door, Molding - Scratch - Small / (L) Front Fender, Molding - Scratch - Minimal / Bonnet, Headlight - Dent - Minimal / Front Bumper, Grille, Lamps - Scratch - Medium
