General Information

Date & Time: 20, Feb, 2026 14:07

Make	Toyota	Model	Vios
YOM	2020	Odo Meter Reading	36,980
Registration No.	VAA9005	Chassis No.	PA1B18F3XK4104582
CC	1.3	Transmission	A/T
Fuel Type	Gas	Type of Body	Sedan
Colour	Silver

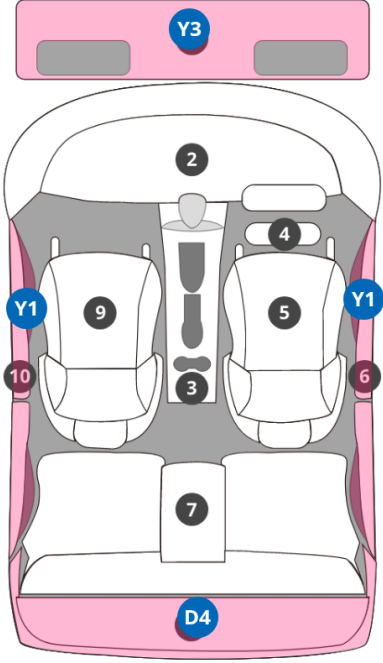
Interior Evaluation : C	Exterior Evaluation : E

<p>a : Cut, Fray d : Loose, Deformed k : Animal Hair s : Smell t : Cigarette Burns x : Defective y : Stain</p>

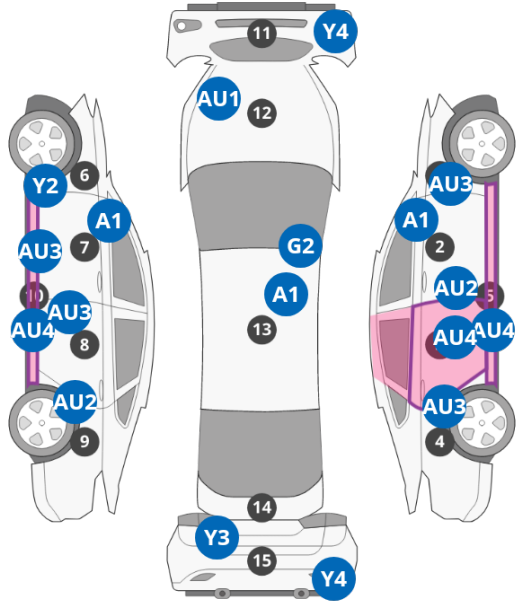
<p>A : Scratch AU : Scratch & Dent B : Modified C : Corrosion G : Stone chip P : Faded S : Rust SC : Rust & Corrosion U : Dent X : Defective Y : Crack, Gap</p>
<p>Remarks Ceiling - Grime - Medium / Trunk Room - Worked - Large / (L) Front Trim - Grime - Minimal / (R) Front Trim - Grime - Minimal</p>	<p>Remarks (R) Step - Repair Traces - Yes / (L) Front Fender - Repair Traces - Yes / (L) Step - Repair Traces - Yes / (R) Rear Fender - Repair Traces - Yes / (R) Front Fender, Molding - Scratch & Dent - Medium / (R) Mirror - Scratch - Minimal / (R) Front Door, Molding - Scratch & Dent - Small / (R) Step, In-panel, Side Spoiler - Scratch & Dent - Large / (R) Rear Door, Molding - Scratch & Dent - Large / (R) Step, In-panel, Side Spoiler - Repair mark - Yes / (R) Rear Door, Molding - Repair mark - Yes / (R) Rear Fender, Molding - Scratch & Dent - Medium / Rear Bumper, Lamps, Panels - Crack, Gap - Large / Trunk Hood, Rear Gate - Crack, Gap - Medium / (L) Rear Fender, Molding - Scratch & Dent - Small / (L) Step, In-panel, Side Spoiler - Repair mark - Yes / (L) Step, In-panel, Side Spoiler - Scratch & Dent - Large / (L) Rear Door, Molding - Scratch & Dent - Medium / (L) Mirror - Scratch - Minimal / (L) Front Door, Molding - Scratch & Dent - Medium / (L) Front Fender, Molding - Crack, Gap - Small / Front Bumper, Grille, Lamps - Crack, Gap - Large / Bonnet, Headlight - Scratch & Dent - Minimal / Front Windshield - Scratch, Stone chip - Small / Roof - Scratch - Minimal</p>
