General Information

Make	Toyota	Model	Avanza
YOM	2020	Odo Meter Reading	89,803
Registration No.	HAC4125	Chassis No.	MHKM5EE1FLK006705
CC	1.3	Transmission	M/T
Fuel Type	Gas	Type of Body	Wagon
Colour	Gray

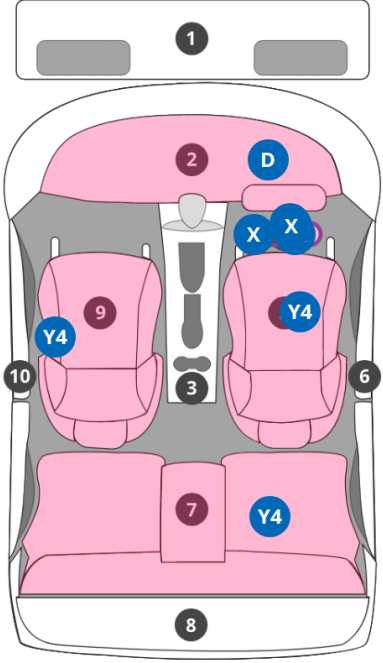
Interior Evaluation : C	Exterior Evaluation : E

<p>a : Cut, Fray d : Loose, Deformed k : Animal Hair s : Smell t : Cigarette Burns x : Defective y : Stain</p>

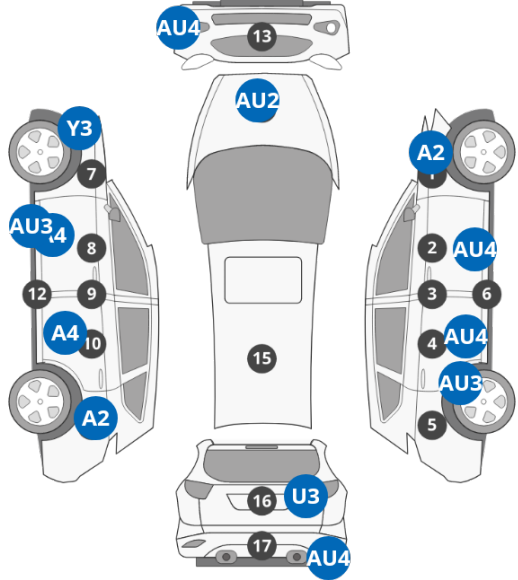
<p>A : Scratch AU : Scratch & Dent B : Modified C : Corrosion G : Stone chip P : Faded S : Rust SC : Rust & Corrosion U : Dent X : Defective Y : Crack, Gap</p>
<p>Remarks Rear Seat - Grime - Large / Mat Other - Missing - Yes / Carpet - Worn, Scratch, Cut, Crack - Large / (R) Front Seat - Grime - Large / (L) Front Floor Mat - Missing - Yes / (R) Front Floor Mat - Missing - Yes / Dashboard - Traces of Adhesive Tape - Yes / (L) Front Seat - Grime - Large</p>	<p>Remarks (R) Step - Repair Traces - Yes / (L) Rear Door, Molding - Scratch - Large / (L) Front Door, Molding - Scratch - Large / (L) Step, In-panel, Side Spoiler - Scratch & Dent - Medium / (L) Front Fender, Molding - Crack, Gap - Medium / Front Bumper, Grille, Lamps - Scratch & Dent - Large / (L) Rear Fender, Molding - Scratch - Small / Trunk Hood, Rear Gate - Dent - Medium / Rear Bumper, Lamps, Panels - Scratch & Dent - Large / (R) Rear Fender, Molding - Scratch & Dent - Medium / (R) Rear Door, Molding - Scratch & Dent - Large / (R) Front Door, Molding - Scratch & Dent - Large / (R) Front Fender, Molding - Scratch - Small / Bonnet, Headlight - Scratch & Dent - Small</p>
