General Information

Make	Hyundai	Model	Stargazer
YOM	2024	Odo Meter Reading	47,026
Registration No.	FAQ2625	Chassis No.	MF3NB81DERJ037120
CC	1.5	Transmission	CVT
Fuel Type	Gas	Type of Body	MPV
Colour	White

Body / Panel Condition

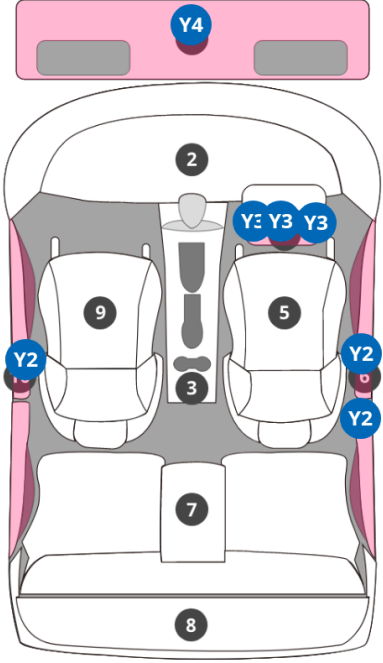
Interior Evaluation : C	Exterior Evaluation : E

<p>a : Cut, Fray d : Loose, Deformed k : Animal Hair s : Smell t : Cigarette Burns x : Defective y : Stain</p>

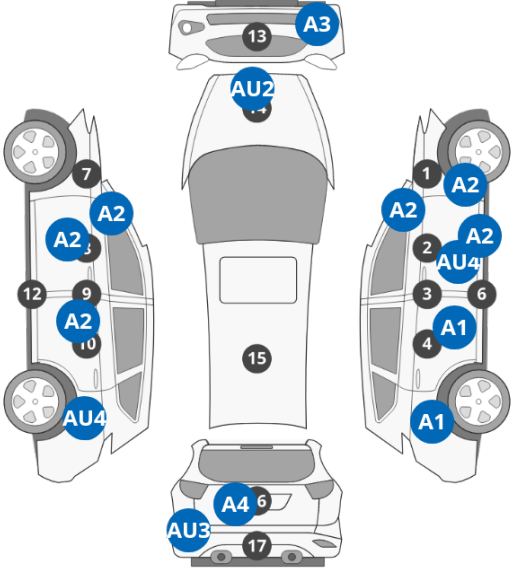
<p>A : Scratch AU : Scratch & Dent B : Modified C : Corrosion G : Stone chip P : Faded S : Rust SC : Rust & Corrosion U : Dent X : Defective Y : Crack, Gap</p>
<p>Remarks (L) Front Floor Mat - Grime - Medium / (L) Front Trim - Grime - Small / Mat Other - Grime - Medium / Ceiling - Grime - Large / (R) Rear Trim - Grime - Small / (R) Front Floor Mat - Grime - Medium / (R) Front Trim - Grime - Small</p>	<p>Remarks (L) Mirror - Scratch - Small / (L) Rear Door, Molding - Scratch - Small / (L) Front Door, Molding - Scratch - Small / (L) Rear Fender, Molding - Scratch & Dent - Large / Trunk Hood, Rear Gate - Scratch - Large / Rear Bumper, Lamps, Panels - Scratch & Dent - Medium / (R) Rear Fender, Molding - Scratch - Minimal / (R) Front Door, Molding - Scratch & Dent - Large / (R) Step, In-panel, Side Spoiler - Scratch - Small / (R) Rear Door, Molding - Scratch - Minimal / (R) Mirror - Scratch - Small / (R) Front Fender, Molding - Scratch - Small / Bonnet, Headlight - Scratch & Dent - Small / Front Bumper, Grille, Lamps - Scratch - Medium</p>
