## General Information

<b>Make</b>	Mitsubishi	<b>Model</b>	L300
<b>YOM</b>	2025	<b>Odo Meter Reading</b>	1,497
<b>Registration No.</b>	NKP2137	<b>Chassis No.</b>	PAEL65NYSSB002449
<b>CC</b>	2.2	<b>Transmission</b>	M/T
<b>Fuel Type</b>	Diesel	<b>Type of Body</b>	FB Body
<b>Colour</b>	White

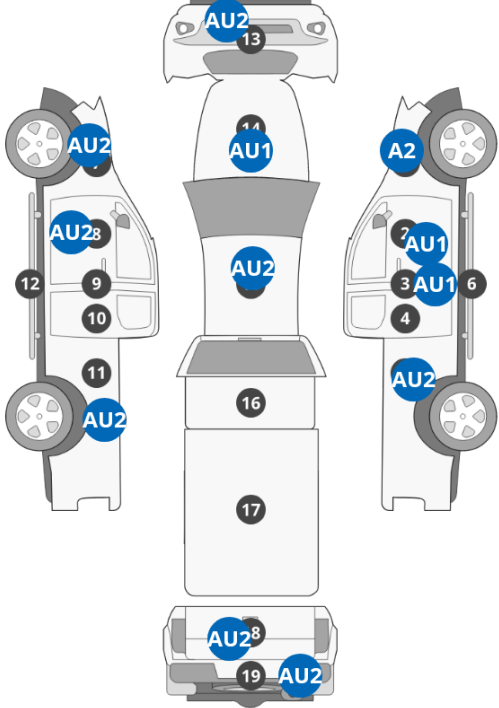
<p><b>A</b> : Scratch <b>AU</b> : Scratch &amp; Dent <b>B</b> : Modified <b>C</b> : Corrosion <b>G</b> : Stone chip <b>P</b> : Faded <b>S</b> : Rust <b>SC</b> : Rust &amp; Corrosion <b>U</b> : Dent <b>X</b> : Defective <b>Y</b> : Crack, Gap</p>
<p><b>Remarks</b> (L) Front Seat - Grime - Small / (R) Front Seat - Grime - Small / Rear Seat - Grime - Minimal / (L) Front Trim - Grime - Minimal / (R) Front Trim - Grime - Small / Ceiling - Grime - Minimal / (L) Front Floor Mat - Grime - Minimal</p>	<p><b>Remarks</b> (L) Side Gate - Scratch &amp; Dent - Small / (L) Front Door, Molding - Scratch &amp; Dent - Small / (L) Front Fender, Molding - Scratch &amp; Dent - Small / Front Panel - Scratch &amp; Dent - Minimal / Front Bumper, Grille, Lamps - Scratch &amp; Dent - Small / (R) Front Fender, Molding - Scratch - Small / (R) Front Door, Molding - Scratch &amp; Dent - Minimal / (R) Center Panel - Scratch &amp; Dent - Minimal / Roof - Scratch &amp; Dent - Small / (R) Side Gate - Scratch &amp; Dent - Small / Rear Gate - Scratch &amp; Dent - Small</p>
