## General Information

<b>Make</b>	Toyota	<b>Model</b>	Vios
<b>YOM</b>	2025	<b>Odo Meter Reading</b>	13,925
<b>Registration No.</b>	NGC9132	<b>Chassis No.</b>	PA1B18F3XR4267176
<b>CC</b>	1.3	<b>Transmission</b>	CVT
<b>Fuel Type</b>	Gas	<b>Type of Body</b>	Sedan
<b>Colour</b>	Blue

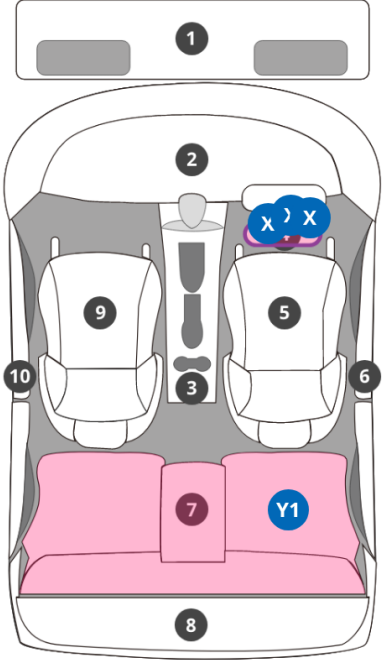
<b>Interior Evaluation :</b> <span style="float: right; color: red; font-weight: bold;">B</span>	<b>Exterior Evaluation :</b> <span style="float: right; color: red; font-weight: bold;">C</span>

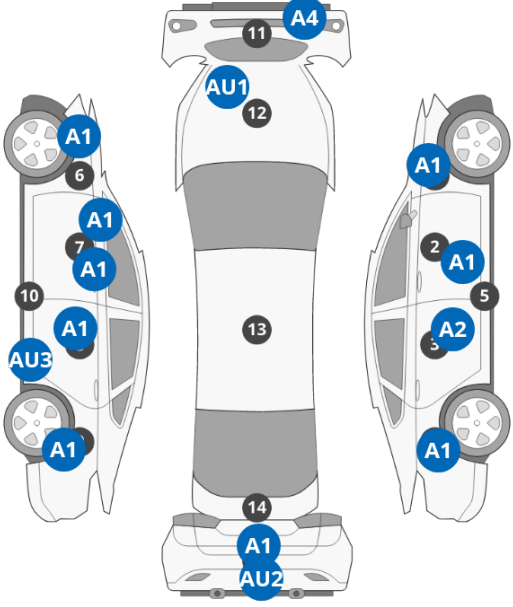
<p><b>A</b> : Scratch <b>AU</b> : Scratch &amp; Dent <b>B</b> : Modified <b>C</b> : Corrosion <b>G</b> : Stone chip <b>P</b> : Faded <b>S</b> : Rust <b>SC</b> : Rust &amp; Corrosion <b>U</b> : Dent <b>X</b> : Defective <b>Y</b> : Crack, Gap</p>
<p><b>Remarks</b> (R) Front Floor Mat - Missing - Yes / (L) Front Floor Mat - Missing - Yes / Mat Other - Missing - Yes / Rear Seat - Grime - Minimal</p>	<p><b>Remarks</b> (R) Front Fender, Molding - Scratch - Minimal / (R) Front Door, Molding - Scratch - Minimal / (R) Rear Door, Molding - Scratch - Small / (R) Rear Fender, Molding - Scratch - Minimal / Rear Bumper, Lamps, Panels - Scratch &amp; Dent - Small / Trunk Hood, Rear Gate - Scratch - Minimal / (L) Rear Fender, Molding - Scratch - Minimal / (L) Rear Door, Molding - Scratch - Minimal / (L) Step, In-panel, Side Spoiler - Scratch &amp; Dent - Medium / (L) Front Door, Molding - Scratch - Minimal / (L) Mirror - Scratch - Minimal / (L) Front Fender, Molding - Scratch - Minimal / Front Bumper, Grille, Lamps - Scratch - Large / Bonnet, Headlight - Scratch &amp; Dent - Minimal</p>
