## General Information

Date & Time: 23, Feb, 2026 14:05

<b>Make</b>	Toyota	<b>Model</b>	Vios
<b>YOM</b>	2022	<b>Odo Meter Reading</b>	62,953
<b>Registration No.</b>	DAS3578	<b>Chassis No.</b>	PA1B18F34N4187334
<b>CC</b>	1.3	<b>Transmission</b>	CVT
<b>Fuel Type</b>	Gas	<b>Type of Body</b>	Sedan
<b>Colour</b>	Red Mica Metallic

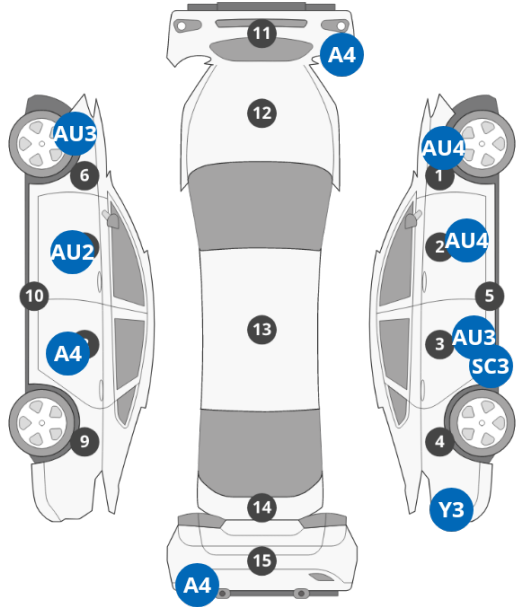
<p><b>A</b> : Scratch <b>AU</b> : Scratch &amp; Dent <b>B</b> : Modified <b>C</b> : Corrosion <b>G</b> : Stone chip <b>P</b> : Faded <b>S</b> : Rust <b>SC</b> : Rust &amp; Corrosion <b>U</b> : Dent <b>X</b> : Defective <b>Y</b> : Crack, Gap</p>
<p><b>Remarks</b> Rear Seat - Grime - Large / (R) Front Trim - Grime - Small / (L) Front Trim - Grime - Medium</p>	<p><b>Remarks</b> Bonnet - Repair Traces - Yes / Roof - Repair Traces - Yes / (R) Front Fender, Molding - Scratch &amp; Dent - Large / Front Bumper, Grille, Lamps - Scratch - Large / (R) Front Door, Molding - Scratch &amp; Dent - Large / (R) Step, In-panel, Side Spoiler - Rust, Corrosion - Medium / (R) Rear Door, Molding - Scratch &amp; Dent - Medium / Rear Bumper, Lamps, Panels - Scratch - Large / (R) Rear Fender, Molding - Crack, Gap - Medium / (L) Rear Door, Molding - Scratch - Large / (L) Front Door, Molding - Scratch &amp; Dent - Small / (L) Front Fender, Molding - Scratch &amp; Dent - Medium</p>
