## General Information

<b>Make</b>	Toyota	<b>Model</b>	Vios
<b>YOM</b>	2022	<b>Odo Meter Reading</b>	175,063
<b>Registration No.</b>	DAR3949	<b>Chassis No.</b>	PA1B18F30N4182566
<b>CC</b>	1.3	<b>Transmission</b>	CVT
<b>Fuel Type</b>	Gas	<b>Type of Body</b>	Sedan
<b>Colour</b>	Black

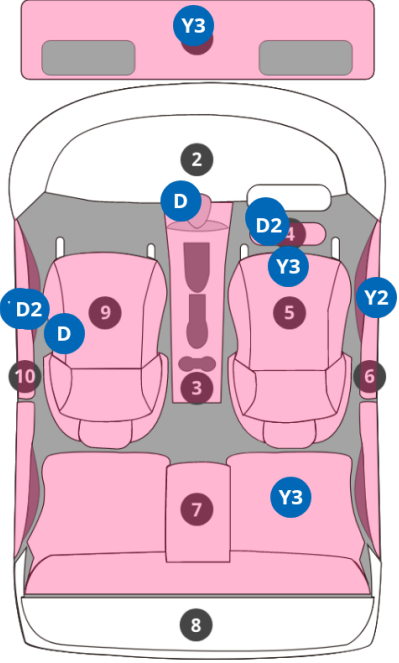
<b>Interior Evaluation :</b> <span style="float: right; color: red; font-weight: bold;">C</span>	<b>Exterior Evaluation :</b> <span style="float: right; color: red; font-weight: bold;">E</span>

<p><b>a</b> : Cut, Fray <b>d</b> : Loose, Deformed <b>k</b> : Animal Hair <b>s</b> : Smell <b>t</b> : Cigarette Burns <b>x</b> : Defective <b>y</b> : Stain</p>

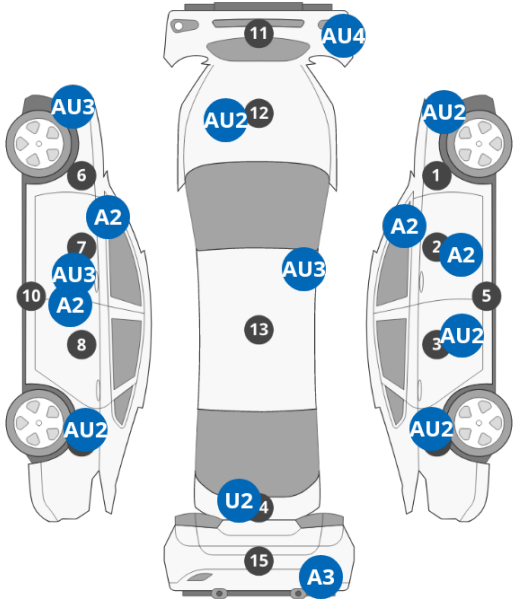
<p><b>A</b> : Scratch <b>AU</b> : Scratch &amp; Dent <b>B</b> : Modified <b>C</b> : Corrosion <b>G</b> : Stone chip <b>P</b> : Faded <b>S</b> : Rust <b>SC</b> : Rust &amp; Corrosion <b>U</b> : Dent <b>X</b> : Defective <b>Y</b> : Crack, Gap</p>
<p><b>Remarks</b> (R) Front Seat - Grime - Medium / (L) Front Seat - Worn - Yes / (L) Front Floor Mat - Cut, Crack - Minimal / (L) Front Floor Mat - Worked - Small / (R) Front Trim - Grime - Small / (L) Front Trim - Grime - Small / (L) Front Trim - Worked - Small / Overall Interior - Worn as per age - Yes / Rear Seat - Grime - Medium / Ceiling - Grime - Medium / Console, Switchs, Vents - Traces of Adhesive Tape - Yes</p>	<p><b>Remarks</b> Trunk Hood, Rear Gate - Repair Traces - Yes / (R) Front Fender, Molding - Scratch &amp; Dent - Small / Overall Exterior - Worn as per age - Yes / (R) Mirror - Scratch - Small / (R) Front Door, Molding - Scratch - Small / (R) Rear Door, Molding - Scratch &amp; Dent - Small / Roof - Scratch &amp; Dent - Medium / (R) Rear Fender, Molding - Scratch &amp; Dent - Small / Trunk Hood, Rear Gate - Dent - Small / Rear Bumper, Lamps, Panels - Scratch - Medium / (L) Rear Fender, Molding - Scratch &amp; Dent - Small / (L) Front Door, Molding - Scratch &amp; Dent - Medium / (L) Rear Door, Molding - Scratch - Small / (L) Front Fender, Molding - Scratch &amp; Dent - Medium / (L) Mirror - Scratch - Small / Front Bumper, Grille, Lamps - Scratch &amp; Dent - Large / Bonnet, Headlight - Scratch &amp; Dent - Small</p>
