## General Information

| Make | Toyota | Model | Vios |
| Registration No. | DAP5981 | Chassis No. | PA1B18F30N4169820 |

## Body / Panel Condition

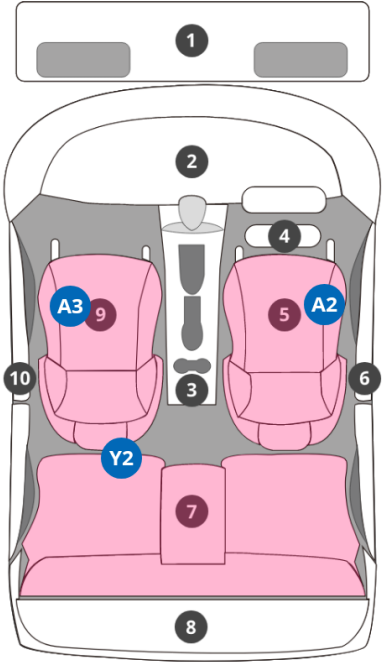
| Interior Evaluation : <b>B</b> | Exterior Evaluation : <b>C</b> |
| <b>Remarks</b><br>(R) Front Seat - Cut, Crack - Small / Rear Seat - Grime - Small / (L) Front Seat - Cut, Crack - Medium | <b>Remarks</b><br>(R) Front Door - Repair Traces - Yes / (R) Front Fender - Repair Traces - Yes / Bonnet - Repair Traces - Yes / (R) Rear Fender - Repair Traces - Yes / (R) Rear Door - Repair Traces - Yes / Front Bumper, Grille, Lamps - Scratch - Large / (R) Front Fender, Molding - Scratch - Medium / (R) Front Door, Molding - Scratch & Dent - Medium / (R) Rear Door, Molding - Scratch & Dent - Small / (R) Rear Fender, Molding - Scratch & Dent - Small / Rear Bumper, Lamps, Panels - Scratch - Large / Roof - Dent - Small |
