## General Information

<b>Make</b>	Toyota	<b>Model</b>	Veloz
<b>YOM</b>	2024	<b>Odo Meter Reading</b>	51,351
<b>Registration No.</b>	DBN1392	<b>Chassis No.</b>	MHFAB1BY3P3068765
<b>CC</b>	1.5	<b>Transmission</b>	CVT
<b>Fuel Type</b>	Gas	<b>Type of Body</b>	SUV
<b>Colour</b>	Black

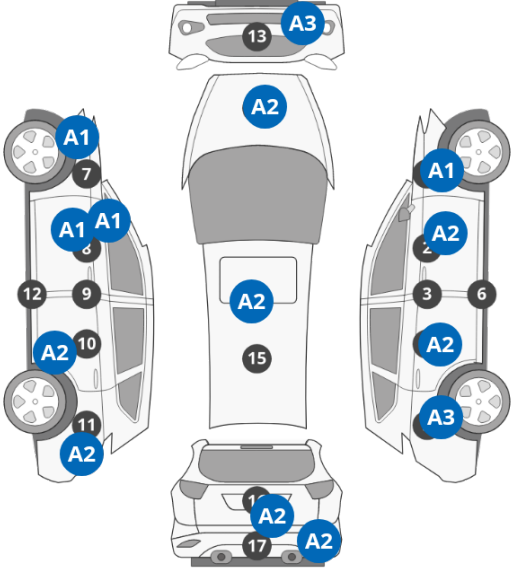
<p><b>A</b> : Scratch <b>AU</b> : Scratch &amp; Dent <b>B</b> : Modified <b>C</b> : Corrosion <b>G</b> : Stone chip <b>P</b> : Faded <b>S</b> : Rust <b>SC</b> : Rust &amp; Corrosion <b>U</b> : Dent <b>X</b> : Defective <b>Y</b> : Crack, Gap</p>
<p><b>Remarks</b> (R) Front Seat - Grime - Large / Rear Seat - Grime - Medium / (L) Front Seat - Grime - Small / Console, Switchs, Vents - Traces of Adhesive Tape - Yes / Ceiling - Grime - Small</p>	<p><b>Remarks</b> (L) Mirror - Scratch - Minimal / (L) Front Door, Molding - Scratch - Minimal / (L) Rear Door, Molding - Scratch - Small / (L) Front Fender, Molding - Scratch - Minimal / (L) Rear Fender, Molding - Scratch - Small / Trunk Hood, Rear Gate - Scratch - Small / Rear Bumper, Lamps, Panels - Scratch - Small / (R) Rear Fender, Molding - Scratch - Medium / (R) Rear Door, Molding - Scratch - Small / (R) Front Door, Molding - Scratch - Small / (R) Front Fender, Molding - Scratch - Minimal / Bonnet, Headlight - Scratch - Small / Front Bumper, Grille, Lamps - Scratch - Medium / Roof - Scratch - Small</p>
