## General Information

<b>Make</b>	Mitsubishi	<b>Model</b>	L300
<b>YOM</b>	2016	<b>Odo Meter Reading</b>	156,182
<b>Registration No.</b>	NDS1503	<b>Chassis No.</b>	PAEL35MYGFB025977
<b>CC</b>	2.5	<b>Transmission</b>	M/T
<b>Fuel Type</b>	Diesel	<b>Type of Body</b>	Utility Vehicle
<b>Colour</b>	White

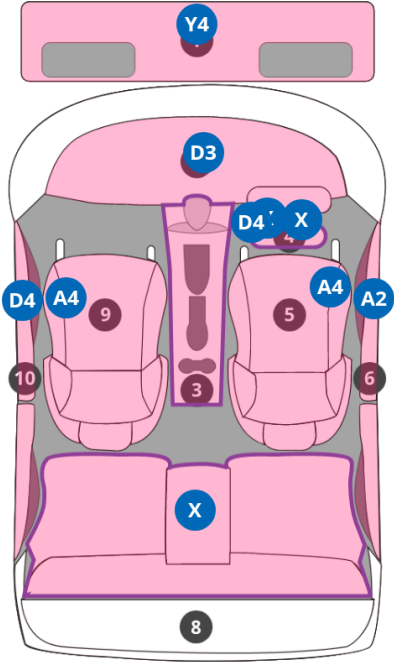
<p><b>A</b> : Scratch <b>AU</b> : Scratch &amp; Dent <b>B</b> : Modified <b>C</b> : Corrosion <b>G</b> : Stone chip <b>P</b> : Faded <b>S</b> : Rust <b>SC</b> : Rust &amp; Corrosion <b>U</b> : Dent <b>X</b> : Defective <b>Y</b> : Crack, Gap</p>
<p><b>Remarks</b> Ceiling - Grime - Large / Overall Interior - Worn as per age - Yes / (R) Front Floor Mat - Missing - Yes / (L) Front Floor Mat - Missing - Yes / Carpet - Loose, Deformed - Large / Glove Box - Loose, Deformed - Medium / Display, Audio System - Partially Missing - Yes / (R) Front Seat - Cut, Crack - Large / (R) Front Trim - Cut, Crack - Small / (L) Front Seat - Cut, Crack - Large / (L) Front Trim - Worked - Large / Rear Seat - Missing - Yes</p>	<p><b>Remarks</b> (R) Front Door - Repair Traces - Yes / Front Panel - Repair Traces - Yes / (L) Front Door - Repair Traces - Yes / (L) Rear Corner Panel - Repair Traces - Yes / (R) Rear Corner Panel - Repair Traces - Yes / Roof - Repair Traces - Yes / (R) Front Fender, Molding - Scratch - Small / (R) Mirror - Scratch - Minimal / (R) Front Door, Molding - Repair mark - Yes / (R) Side Gate - Repair mark - Difference in Color / (R) Front Door, Molding - Scratch &amp; Dent - Large / (R) Center Panel - Scratch - Medium / Roof - Rust, Corrosion - Large / (R) Side Gate - Scratch &amp; Dent - Large / Rear Bumper, Lamps, Panels - Repair mark - Yes / Rear Gate - Modified - Medium / Rear Bumper, Lamps, Panels - Scratch &amp; Dent - Medium / (L) Side Gate - Repair mark - Difference in Color / (L) Side Gate - Scratch &amp; Dent - Large / (L) Center Panel - Scratch &amp; Dent - Minimal / (L) Front Door, Molding - Scratch &amp; Dent - Large / (L) Mirror - Scratch - Minimal / (L) Front Fender, Molding - Scratch - Small / Front Panel - Scratch &amp; Dent - Medium / Front Bumper, Grille, Lamps - Crack, Gap - Large / Antennae - Damaged - Yes</p>
