## General Information

Make	Mitsubishi	Model	Xpander
YOM	2023	Odo Meter Reading	35,416
Registration No.	NIE6189	Chassis No.	MK2LRNC1WPN004792
CC	1.5	Transmission	A/T
Fuel Type	Gas	Type of Body	Wagon
Colour	Silver

## Body / Panel Condition

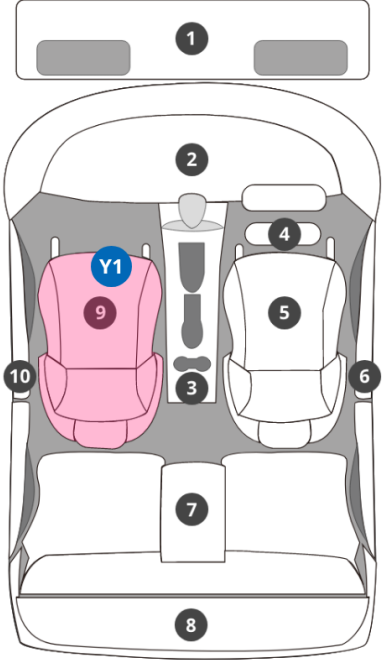
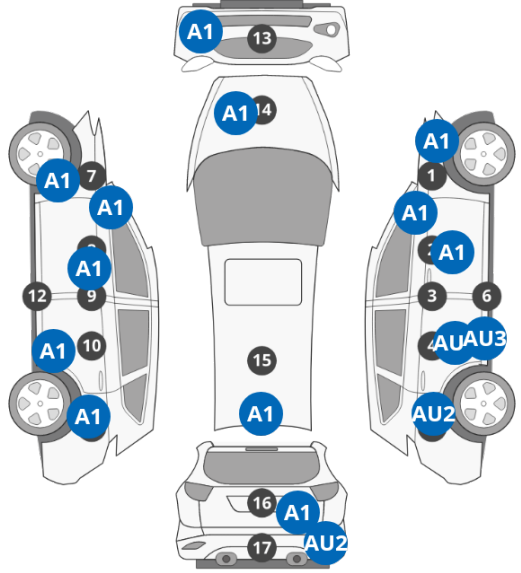
<b>Interior Evaluation :</b>	A	<b>Exterior Evaluation :</b>	C

<p><b>a</b> : Cut, Fray <b>d</b> : Loose, Deformed <b>k</b> : Animal Hair <b>s</b> : Smell <b>t</b> : Cigarette Burns <b>x</b> : Defective <b>y</b> : Stain</p>		<p><b>A</b> : Scratch <b>AU</b> : Scratch &amp; Dent <b>B</b> : Modified <b>C</b> : Corrosion <b>G</b> : Stone chip <b>P</b> : Faded <b>S</b> : Rust <b>SC</b> : Rust &amp; Corrosion <b>U</b> : Dent <b>X</b> : Defective <b>Y</b> : Crack, Gap</p>	
<p><b>Remarks</b> (L) Front Seat - Grime - Minimal</p>		<p><b>Remarks</b> (R) Front Fender, Molding - Scratch - Minimal / (R) Mirror - Scratch - Minimal / (R) Front Door, Molding - Scratch - Minimal / (R) Rear Door, Molding - Scratch &amp; Dent - Large / (R) Step, In-panel, Side Spoiler - Scratch &amp; Dent - Medium / (R) Rear Fender, Molding - Scratch &amp; Dent - Small / Rear Bumper, Lamps, Panels - Scratch &amp; Dent - Small / Roof Spoiler, Molding - Scratch - Minimal / Trunk Hood, Rear Gate - Scratch - Minimal / (L) Rear Fender, Molding - Scratch - Minimal / (L) Rear Door, Molding - Scratch - Minimal / (L) Mirror - Scratch - Minimal / (L) Front Door, Molding - Scratch - Minimal / (L) Front Fender, Molding - Scratch - Minimal / Front Bumper, Grille, Lamps - Scratch - Minimal / Bonnet, Headlight - Scratch - Minimal</p>
