## General Information

Date & Time: 21, Feb, 2026 10:35

<b>Make</b>	Hyundai	<b>Model</b>	Accent
<b>YOM</b>	2020	<b>Odo Meter Reading</b>	32,539
<b>Registration No.</b>	CBL1157	<b>Chassis No.</b>	PEHC741BBLH008900
<b>CC</b>	1.4	<b>Transmission</b>	A/T
<b>Fuel Type</b>	Gas	<b>Type of Body</b>	Sedan
<b>Colour</b>	Gray

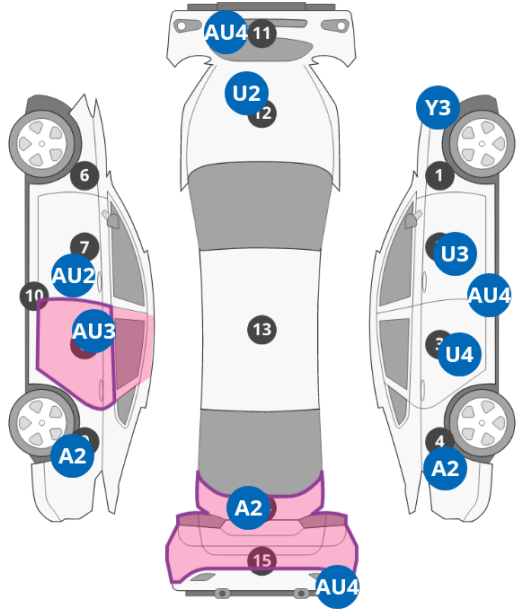
<p><b>A</b> : Scratch <b>AU</b> : Scratch &amp; Dent <b>B</b> : Modified <b>C</b> : Corrosion <b>G</b> : Stone chip <b>P</b> : Faded <b>S</b> : Rust <b>SC</b> : Rust &amp; Corrosion <b>U</b> : Dent <b>X</b> : Defective <b>Y</b> : Crack, Gap</p>
<p><b>Remarks</b> Mat Other - Missing - Yes / Rear Seat - Grime - Medium / Overall Interior - Worn as per age - Yes</p>	<p><b>Remarks</b> (R) Front Door - Repair Traces - Yes / (R) Step - Repair Traces - Yes / (R) Front Fender - Repair Traces - Yes / Bonnet - Repair Traces - Yes / (L) Front Fender - Repair Traces - Yes / (L) Front Door - Repair Traces - Yes / (L) Step - Repair Traces - Yes / (L) Rear Door - Repair Traces - Yes / (L) Rear Fender - Repair Traces - Yes / Trunk Hood, Rear Gate - Repair Traces - Yes / (R) Rear Door - Repair Traces - Yes / Roof - Repair Traces - Yes / Front Bumper, Grille, Lamps - Scratch &amp; Dent - Large / (L) Front Door, Molding - Scratch &amp; Dent - Small / (L) Rear Door, Molding - Partially Missing - Yes / (L) Rear Door, Molding - Scratch &amp; Dent - Medium / (L) Rear Fender, Molding - Scratch - Small / Rear Bumper, Lamps, Panels - Scratch &amp; Dent - Large / (R) Step, In-panel, Side Spoiler - Scratch &amp; Dent - Large / (R) Front Door, Molding - Dent - Medium / (R) Rear Door, Molding - Dent - Large / (R) Front Fender, Molding - Crack, Gap - Medium / Bonnet, Headlight - Dent - Small / Trunk Hood, Rear Gate - Scratch - Small / Trunk Hood, Rear Gate - Repair mark - Yes / (R) Rear Fender, Molding - Scratch - Small</p>
