## General Information

<b>Make</b>	Toyota	<b>Model</b>	Hilux
<b>YOM</b>	2025	<b>Odo Meter Reading</b>	42,566
<b>Registration No.</b>	BAG7817	<b>Chassis No.</b>	MR0AB8DD2R5153703
<b>CC</b>	2.4	<b>Transmission</b>	A/T
<b>Fuel Type</b>	Diesel	<b>Type of Body</b>	Pickup
<b>Colour</b>	Red

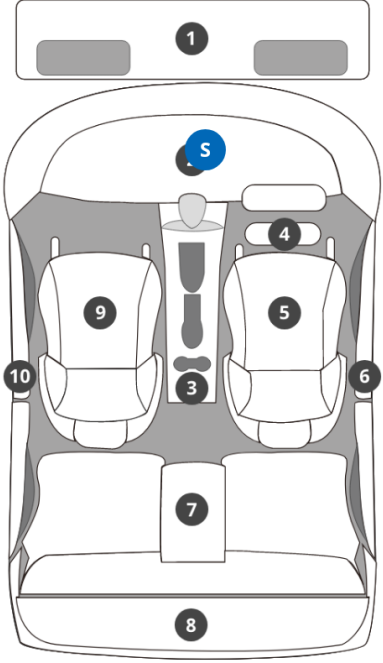
<b>Interior Evaluation :</b> <span style="float: right; color: red; font-weight: bold;">B</span>	<b>Exterior Evaluation :</b> <span style="float: right; color: red; font-weight: bold;">E</span>

<p><b>A</b> : Scratch <b>AU</b> : Scratch &amp; Dent <b>B</b> : Modified <b>C</b> : Corrosion <b>G</b> : Stone chip <b>P</b> : Faded <b>S</b> : Rust <b>SC</b> : Rust &amp; Corrosion <b>U</b> : Dent <b>X</b> : Defective <b>Y</b> : Crack, Gap</p>
<p><b>Remarks</b> Overall Interior - Smell - Yes</p>	<p><b>Remarks</b> (L) Front Fender, Molding - Scratch &amp; Dent - Large / Front Bumper, Grille, Lamps - Crack, Gap - Medium / Front Windshield - Damaged - Large / Rear Bumper, Lamps, Panels - Crack, Gap - Medium / Rear Gate - Dent - Small / Roof - Scratch - Medium / (L) Side Gate - Scratch - Small / (L) Rear Door, Molding - Scratch - Small / (L) Front Door, Molding - Scratch - Minimal / (R) Front Fender, Molding - Scratch - Minimal / (R) Side Gate - Scratch &amp; Dent - Large</p>
