General Information

| Make | Toyota | Model | Avanza |
| Registration No. | IAG1854 | Chassis No. | MHFAB1BY0R3120467 |

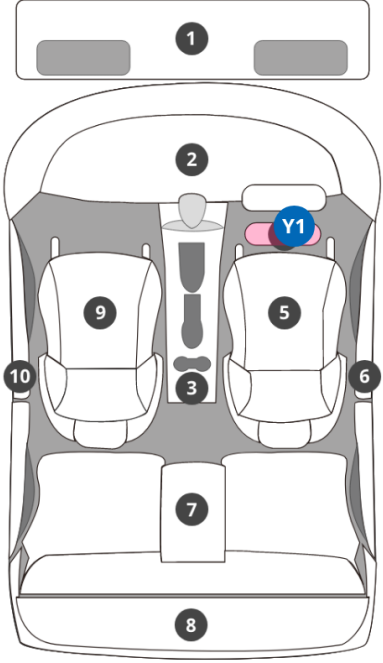
| Interior Evaluation : A | Exterior Evaluation : B |

| Remarks (L) Front Floor Mat - Grime - Minimal | Remarks (R) Front Fender, Molding - Scratch - Minimal / (R) Step, In-panel, Side Spoiler - Scratch - Minimal / (R) Front Door, Molding - Scratch - Minimal / Roof - Scratch - Minimal / (R) Rear Door, Molding - Scratch - Minimal / (R) Rear Fender, Molding - Scratch - Minimal / Roof Spoiler, Molding - Scratch - Minimal / Rear Bumper, Lamps, Panels - Scratch - Minimal / Trunk Hood, Rear Gate - Scratch - Minimal / (L) Rear Fender, Molding - Scratch - Small / (L) Rear Door, Molding - Scratch - Minimal / (L) Step, In-panel, Side Spoiler - Scratch - Minimal / (L) Front Door, Molding - Scratch - Minimal / (L) Mirror - Scratch - Minimal / Bonnet, Headlight - Scratch - Minimal / Front Bumper, Grille, Lamps - Scratch - Minimal |
