## General Information

Date & Time: 21, Feb, 2026 17:37

<b>Make</b>	Toyota	<b>Model</b>	Raize
<b>YOM</b>	2025	<b>Odo Meter Reading</b>	3,880
<b>Registration No.</b>	CCQ6894	<b>Chassis No.</b>	MHKAA1BA9SJ159292
<b>CC</b>	1.0	<b>Transmission</b>	CVT
<b>Fuel Type</b>	Gas	<b>Type of Body</b>	Wagon
<b>Colour</b>	White

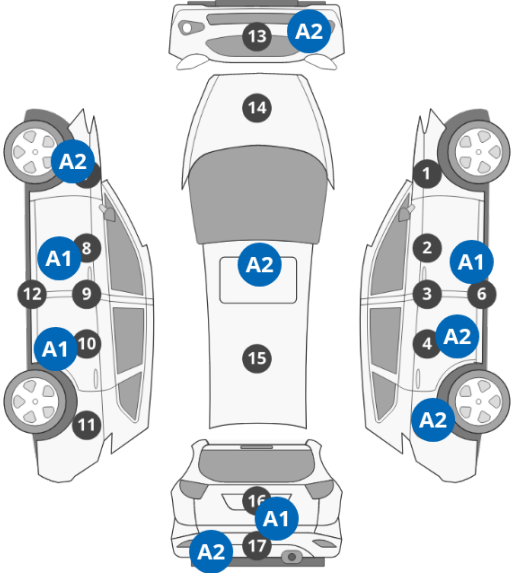
<p><b>A</b> : Scratch <b>AU</b> : Scratch &amp; Dent <b>B</b> : Modified <b>C</b> : Corrosion <b>G</b> : Stone chip <b>P</b> : Faded <b>S</b> : Rust <b>SC</b> : Rust &amp; Corrosion <b>U</b> : Dent <b>X</b> : Defective <b>Y</b> : Crack, Gap</p>
<b>Remarks</b> Defects not found	<b>Remarks</b> (R) Rear Fender, Molding - Scratch - Small / (R) Rear Door, Molding - Scratch - Minimal / (R) Front Door, Molding - Scratch - Small / (L) Front Fender, Molding - Scratch - Small / Front Bumper, Grille, Lamps - Scratch - Small / (L) Front Door, Molding - Scratch - Minimal / (L) Rear Door, Molding - Scratch - Minimal / Rear Bumper, Lamps, Panels - Scratch - Small / Trunk Hood, Rear Gate - Scratch - Minimal / Roof - Scratch - Small
