## General Information

| Make | Toyota | Model | Hiace |
| Registration No. | DBG9200 | Chassis No. | JTFJT02P3P5033410 |

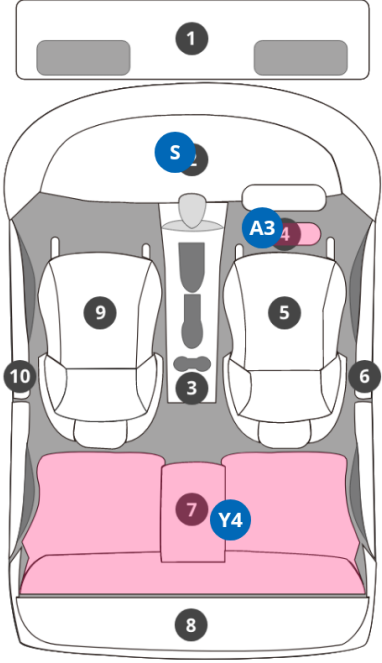
| Interior Evaluation : <span style="color: red;">C</span> | Exterior Evaluation : <span style="color: red;">C</span> |
| <b>Remarks</b><br>(L) Front Floor Mat - Cut, Crack - Medium / Rear Seat - Grime - Large / Overall Interior - Smell - Yes | <b>Remarks</b><br>(R) Rear Fender, Molding - Scratch & Dent - Large / Rear Bumper, Lamps, Panels - Dent - Medium / (L) Rear Fender, Molding - Repair mark - Difference in Color / (L) Rear Door, Molding - Scratch - Small / (R) Front Door, Molding - Repair mark - Difference in Color / Front Bumper, Grille, Lamps - Scratch & Dent - Medium / Roof - Dent - Small / (L) Front Wheel, Cover - Cap Missing - Yes / (L) Rear Wheel, Cover - Cap Missing - Yes / (R) Front Wheel, Cover - Cap Missing - Yes / (R) Rear Wheel, Cover - Cap Missing - Yes |
