## General Information

Date & Time: 23, Feb, 2026 15:50

<b>Make</b>	Toyota	<b>Model</b>	Raize
<b>YOM</b>	2022	<b>Odo Meter Reading</b>	88,516
<b>Registration No.</b>	BAC5272	<b>Chassis No.</b>	MHKAB1BA7NJ015094
<b>CC</b>	1.2	<b>Transmission</b>	CVT
<b>Fuel Type</b>	Gas	<b>Type of Body</b>	Wagon
<b>Colour</b>	Gray

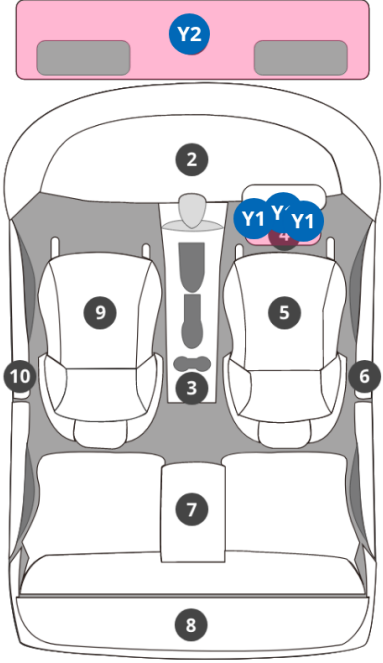
<b>Interior Evaluation :</b> <span style="float: right; color: red; font-weight: bold;">A</span>	<b>Exterior Evaluation :</b> <span style="float: right; color: red; font-weight: bold;">C</span>

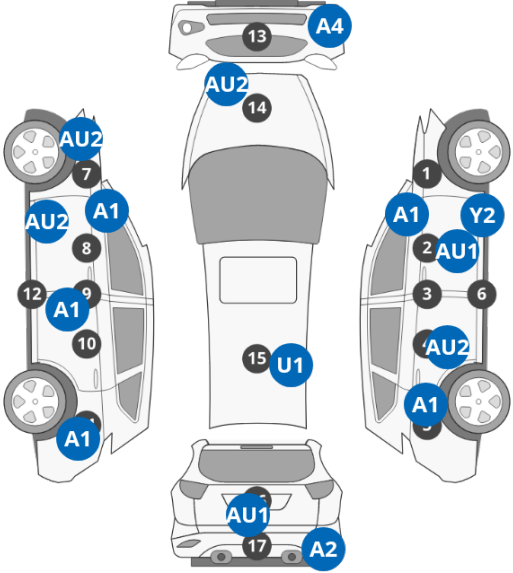
<p><b>A</b> : Scratch <b>AU</b> : Scratch &amp; Dent <b>B</b> : Modified <b>C</b> : Corrosion <b>G</b> : Stone chip <b>P</b> : Faded <b>S</b> : Rust <b>SC</b> : Rust &amp; Corrosion <b>U</b> : Dent <b>X</b> : Defective <b>Y</b> : Crack, Gap</p>
<p><b>Remarks</b> Ceiling - Grime - Small / (R) Front Floor Mat - Grime - Minimal / (L) Front Floor Mat - Grime - Minimal / Mat Other - Grime - Minimal</p>	<p><b>Remarks</b> (R) Front Fender - Repair Traces - Yes / (R) Mirror - Scratch - Minimal / (R) Front Door, Molding - Scratch &amp; Dent - Minimal / (R) Step, In-panel, Side Spoiler - Crack, Gap - Small / (R) Rear Door, Molding - Scratch &amp; Dent - Small / Roof - Dent - Minimal / (R) Rear Fender, Molding - Scratch - Minimal / Rear Bumper, Lamps, Panels - Scratch - Small / Trunk Hood, Rear Gate - Scratch &amp; Dent - Minimal / (L) Rear Fender, Molding - Scratch - Minimal / (L) Rear Door, Molding - Scratch - Minimal / (L) Front Door, Molding - Scratch &amp; Dent - Small / (L) Mirror - Scratch - Minimal / (L) Front Fender, Molding - Scratch &amp; Dent - Small / Bonnet, Headlight - Scratch &amp; Dent - Small / Front Bumper, Grille, Lamps - Scratch - Large</p>
