## General Information

<b>Make</b>	Toyota	<b>Model</b>	Hilux Tamaraw
<b>YOM</b>	2025	<b>Odo Meter Reading</b>	19,467
<b>Registration No.</b>	DCC2951	<b>Chassis No.</b>	PAHACACA7S6426179
<b>CC</b>	2.4	<b>Transmission</b>	M/T
<b>Fuel Type</b>	Diesel	<b>Type of Body</b>	Utility Passenger
<b>Colour</b>	White

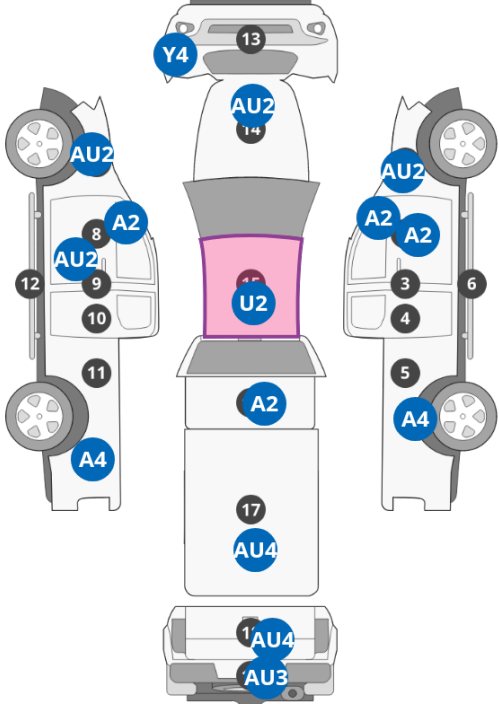
<p><b>A</b> : Scratch <b>AU</b> : Scratch &amp; Dent <b>B</b> : Modified <b>C</b> : Corrosion <b>G</b> : Stone chip <b>P</b> : Faded <b>S</b> : Rust <b>SC</b> : Rust &amp; Corrosion <b>U</b> : Dent <b>X</b> : Defective <b>Y</b> : Crack, Gap</p>
<p><b>Remarks</b> (R) Front Seat - Grime - Small / (L) Front Seat - Grime - Small / (R) Front Trim - Grime - Small / Rear Seat - Grime - Small / Ceiling - Grime - Medium / Dashboard - Worn, Scratch, Cut, Crack - Small / Console, Switches, Vents - Worn, Scratch, Cut, Crack - Small</p>	<p><b>Remarks</b> Roof - Repair Traces - Yes / (L) Front Door, Molding - Scratch &amp; Dent - Small / (L) Front Fender, Molding - Scratch &amp; Dent - Small / (L) Mirror - Scratch - Small / Front Bumper, Grille, Lamps - Crack, Gap - Large / Bonnet, Headlight - Scratch &amp; Dent - Small / (R) Mirror - Scratch - Small / (R) Front Fender, Molding - Scratch &amp; Dent - Small / (R) Front Door, Molding - Scratch - Small / Roof - Dent - Small / Roof - Repair mark - Yes / (R) Guard Frame - Scratch - Large / Rear Bumper, Lamps, Panels - Scratch &amp; Dent - Medium / Rear Gate - Scratch &amp; Dent - Large / (L) Guard Frame - Scratch - Large / Cargo Bed Floor - Scratch &amp; Dent - Large / Cab Back Panel - Scratch - Small</p>
