General Information

| Make | Toyota | Model | Vios |
| Registration No. | NFO7554 | Chassis No. | PA1B18F39N4191279 |

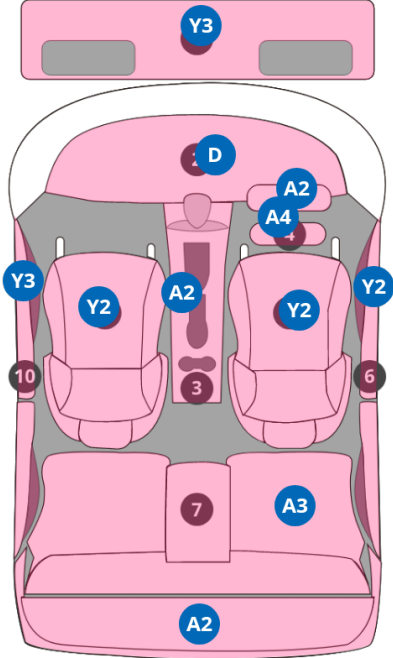
| Interior Evaluation : D | Exterior Evaluation : E |
| <p>Remarks (R) Front Seat - Grime - Small / (R) Front Trim - Grime - Small / Rear Seat - Cut, Crack - Medium / (L) Front Trim - Grime - Medium / (L) Front Floor Mat - Cut, Crack - Large / Steering Wheel - Worn, Peel, Crack - Small / Ceiling - Grime - Medium / Dashboard - Traces of Adhesive Tape - Yes / (L) Front Seat - Grime - Small / Trunk Room - Worn, Scratch, Cut, Crack - Small / Console, Switches, Vents - Worn, Scratch, Cut, Crack - Small</p> | <p>Remarks (L) Front Door, Molding - Scratch & Dent - Large / (L) Front Fender, Molding - Scratch & Dent - Large / (L) Rear Fender, Molding - Scratch - Small / (L) Rear Door, Molding - Scratch & Dent - Large / (L) Step, In-panel, Side Spoiler - Scratch & Dent - Medium / (L) Mirror - Scratch - Small / Bonnet, Headlight - Scratch - Medium / Front Bumper, Grille, Lamps - Scratch - Large / (R) Front Fender, Molding - Scratch & Dent - Medium / (R) Front Door, Molding - Scratch & Dent - Medium / (R) Step, In-panel, Side Spoiler - Scratch & Dent - Large / (R) Rear Door, Molding - Scratch - Large / (R) Rear Fender, Molding - Scratch & Dent - Medium / Trunk Hood, Rear Gate - Scratch - Small / Rear Bumper, Lamps, Panels - Scratch - Large / Roof - Scratch - Small</p> |
