## General Information

<b>Make</b>	Toyota	<b>Model</b>	Raize
<b>YOM</b>	2023	<b>Odo Meter Reading</b>	35,293
<b>Registration No.</b>	NFP9069	<b>Chassis No.</b>	MHKAB1BAXNJ026848
<b>CC</b>	1.2	<b>Transmission</b>	CVT
<b>Fuel Type</b>	Gas	<b>Type of Body</b>	SUV
<b>Colour</b>	Gray

## Body / Panel Condition

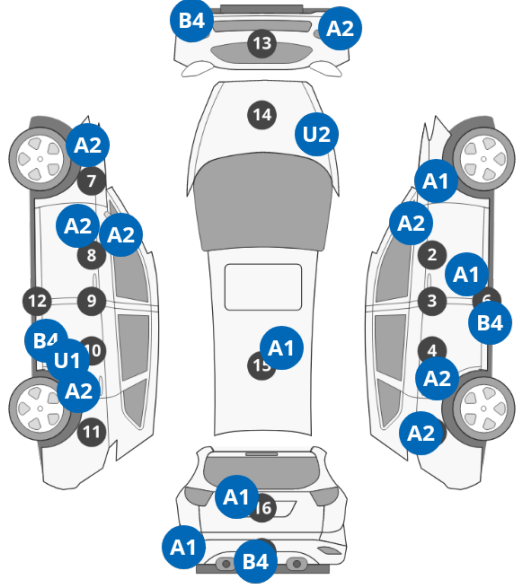
<p><b>A</b> : Scratch <b>AU</b> : Scratch &amp; Dent <b>B</b> : Modified <b>C</b> : Corrosion <b>G</b> : Stone chip <b>P</b> : Faded <b>S</b> : Rust <b>SC</b> : Rust &amp; Corrosion <b>U</b> : Dent <b>X</b> : Defective <b>Y</b> : Crack, Gap</p>
<p><b>Remarks</b> (R) Front Seat - Grime - Medium / (L) Front Seat - Grime - Medium / Rear Seat - Grime - Medium</p>	<p><b>Remarks</b> (L) Rear Door - Repair Traces - Yes / (R) Mirror - Scratch - Small / Bonnet, Headlight - Dent - Small / (R) Front Fender, Molding - Scratch - Minimal / (R) Front Door, Molding - Scratch - Minimal / (R) Rear Door, Molding - Scratch - Small / (R) Step, In-panel, Side Spoiler - Modified - Large / (L) Step, In-panel, Side Spoiler - Modified - Large / (R) Rear Fender, Molding - Scratch - Small / Rear Bumper, Lamps, Panels - Modified - Large / Rear Bumper, Lamps, Panels - Scratch - Minimal / Trunk Hood, Rear Gate - Scratch - Minimal / (L) Rear Fender, Molding - Scratch - Small / (L) Rear Door, Molding - Dent - Minimal / (L) Front Door, Molding - Scratch - Small / (L) Mirror - Scratch - Small / (L) Front Fender, Molding - Scratch - Small / Front Bumper, Grille, Lamps - Modified - Large / Front Bumper, Grille, Lamps - Scratch - Small / Roof - Scratch - Minimal</p>
