## General Information

<b>Make</b>	Toyota	<b>Model</b>	Vios
<b>YOM</b>	2025	<b>Odo Meter Reading</b>	16,296
<b>Registration No.</b>	NHL6668	<b>Chassis No.</b>	PA1B18F35R4279543
<b>CC</b>	1.3	<b>Transmission</b>	CVT
<b>Fuel Type</b>	Gas	<b>Type of Body</b>	Sedan
<b>Colour</b>	Red Mica Metallic

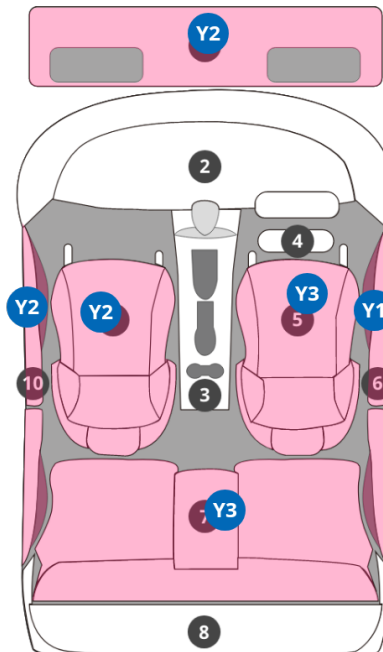
<b>Interior Evaluation :</b> <span style="float: right;"><b>B</b></span>	<b>Exterior Evaluation :</b> <span style="float: right;"><b>E</b></span>

<p><b>a</b> : Cut, Fray <b>d</b> : Loose, Deformed <b>k</b> : Animal Hair <b>s</b> : Smell <b>t</b> : Cigarette Burns <b>x</b> : Defective <b>y</b> : Stain</p>

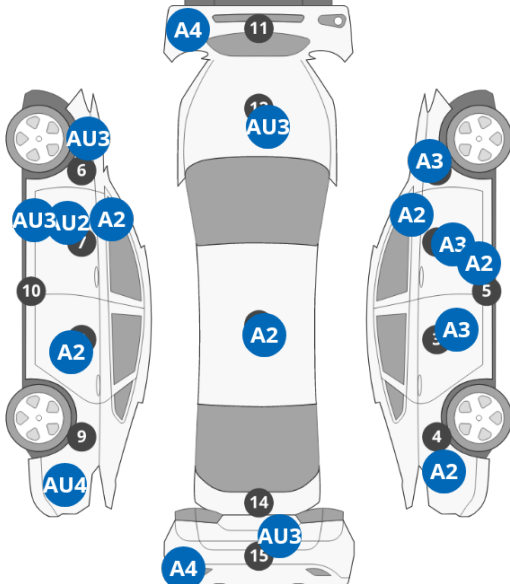
<p><b>A</b> : Scratch <b>AU</b> : Scratch &amp; Dent <b>B</b> : Modified <b>C</b> : Corrosion <b>G</b> : Stone chip <b>P</b> : Faded <b>S</b> : Rust <b>SC</b> : Rust &amp; Corrosion <b>U</b> : Dent <b>X</b> : Defective <b>Y</b> : Crack, Gap</p>
<p><b>Remarks</b> (R) Front Seat - Grime - Medium / (R) Front Trim - Grime - Minimal / Rear Seat - Grime - Medium / (L) Front Seat - Grime - Small / (L) Front Trim - Grime - Small / Ceiling - Grime - Small</p>	<p><b>Remarks</b> (L) Front Fender, Molding - Scratch &amp; Dent - Medium / Front Bumper, Grille, Lamps - Scratch - Large / (L) Mirror - Scratch - Small / (L) Front Door, Molding - Scratch &amp; Dent - Small / (L) Step, In-panel, Side Spoiler - Scratch &amp; Dent - Medium / (L) Rear Door, Molding - Scratch - Small / (L) Rear Fender, Molding - Scratch &amp; Dent - Large / Trunk Hood, Rear Gate - Scratch &amp; Dent - Medium / Rear Bumper, Lamps, Panels - Scratch - Large / (R) Rear Fender, Molding - Scratch - Small / (R) Rear Door, Molding - Scratch - Medium / (R) Front Door, Molding - Scratch - Medium / (R) Step, In-panel, Side Spoiler - Scratch - Small / (R) Mirror - Scratch - Small / (R) Front Fender, Molding - Scratch - Medium / Bonnet, Headlight - Scratch &amp; Dent - Medium / Roof - Scratch - Small</p>
