## General Information

| <b>Make</b> | Toyota | <b>Model</b> | Vios |
| <b>Registration No.</b> | NHR7803 | <b>Chassis No.</b> | PA1B18F3XP4231372 |

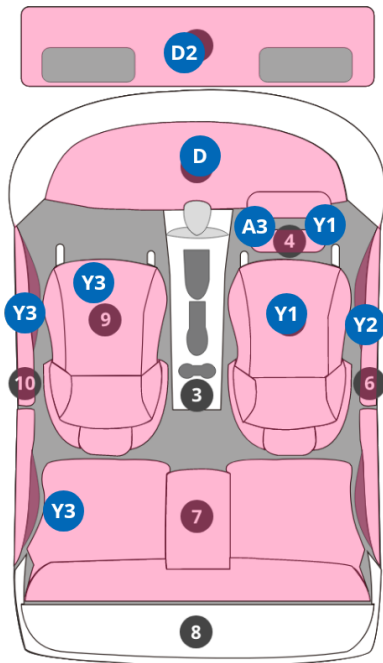
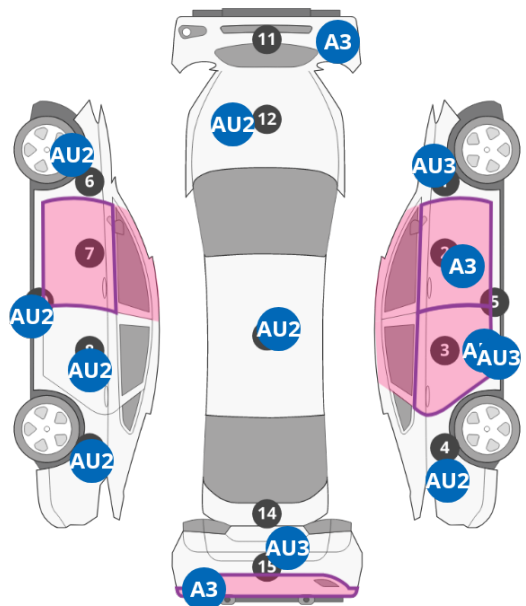
| <b>Interior Evaluation :</b> <span style="float: right; color: red; font-weight: bold;">C</span> | <b>Exterior Evaluation :</b> <span style="float: right; color: red; font-weight: bold;">E</span> |
| <p><b>Remarks</b><br/> (L) Front Floor Mat - Cut, Crack - Medium / (L) Front Seat - Grime - Medium / Rear Seat - Grime - Medium / (R) Front Floor Mat - Grime - Minimal / (L) Front Trim - Grime - Medium / (R) Front Trim - Grime - Small / (R) Front Seat - Grime - Minimal / Ceiling - Crinkle - Small / Instrument Panel - Traces of Adhesive Tape - Yes</p> | <p><b>Remarks</b><br/> (R) Front Fender - Repair Traces - Yes / (L) Front Fender - Repair Traces - Yes / Roof - Scratch &amp; Dent - Small / (L) Rear Door, Molding - Scratch &amp; Dent - Small / (L) Rear Fender, Molding - Scratch &amp; Dent - Small / Rear Bumper, Lamps, Panels - Repair mark - Yes / Rear Bumper, Lamps, Panels - Scratch - Medium / Trunk Hood, Rear Gate - Scratch &amp; Dent - Medium / (R) Rear Fender, Molding - Scratch &amp; Dent - Small / (R) Rear Door, Molding - Scratch &amp; Dent - Medium / (R) Step, In-panel, Side Spoiler - Scratch &amp; Dent - Medium / (R) Rear Door, Molding - Repair mark - Yes / (R) Front Door, Molding - Repair mark - Yes / (R) Front Door, Molding - Scratch - Medium / (R) Front Fender, Molding - Scratch &amp; Dent - Medium / Front Bumper, Grille, Lamps - Scratch - Medium / Bonnet, Headlight - Scratch &amp; Dent - Small / (L) Front Fender, Molding - Scratch &amp; Dent - Small / (L) Front Door, Molding - Repair mark - Yes / (L) Step, In-panel, Side Spoiler - Scratch &amp; Dent - Small</p> |
