## General Information

<b>Make</b>	Toyota	<b>Model</b>	Innova
<b>YOM</b>	2024	<b>Odo Meter Reading</b>	40,565
<b>Registration No.</b>	NKD3127	<b>Chassis No.</b>	PA2CA8EM2R0140892
<b>CC</b>	2.8	<b>Transmission</b>	M/T
<b>Fuel Type</b>	Diesel	<b>Type of Body</b>	Wagon
<b>Colour</b>	White

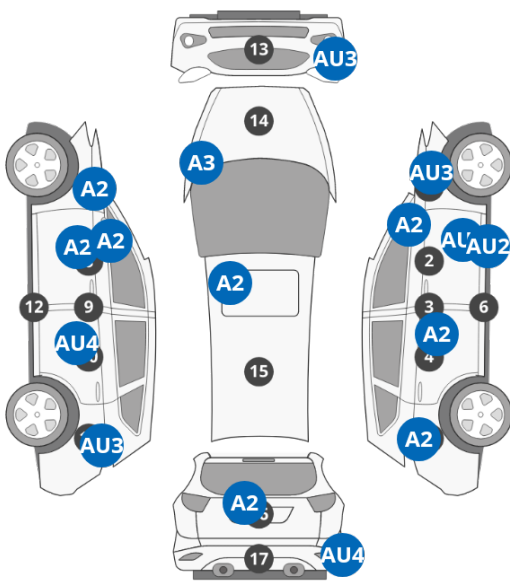
<p><b>A</b> : Scratch <b>AU</b> : Scratch &amp; Dent <b>B</b> : Modified <b>C</b> : Corrosion <b>G</b> : Stone chip <b>P</b> : Faded <b>S</b> : Rust <b>SC</b> : Rust &amp; Corrosion <b>U</b> : Dent <b>X</b> : Defective <b>Y</b> : Crack, Gap</p>
<p><b>Remarks</b> Overall Interior - Worn as per age - Yes / Overall Interior - Smell - Yes / (L) Front Floor Mat - Cut, Crack - Medium / (R) Front Seat - Grime - Medium / Rear Seat - Grime - Large / (R) Front Trim - Grime - Medium / (L) Front Trim - Grime - Medium / (L) Front Seat - Grime - Small / (R) Rear Trim - Grime - Small / (L) Rear Trim - Grime - Small / Dashboard - Traces of Adhesive Tape - Yes / Console, Switches, Vents - Worn, Scratch, Cut, Crack - Small / Mat Other - Worked - Large / Ceiling - Grime - Large</p>	<p><b>Remarks</b> (R) Front Fender, Molding - Scratch &amp; Dent - Medium / (R) Front Door, Molding - Scratch &amp; Dent - Large / (R) Mirror - Scratch - Small / (R) Step, In-panel, Side Spoiler - Scratch &amp; Dent - Small / (R) Rear Door, Molding - Scratch - Small / (R) Rear Fender, Molding - Scratch - Small / Rear Bumper, Lamps, Panels - Scratch &amp; Dent - Large / Trunk Hood, Rear Gate - Scratch - Small / (L) Rear Fender, Molding - Scratch &amp; Dent - Medium / (L) Rear Door, Molding - Scratch &amp; Dent - Large / (L) Front Door, Molding - Scratch - Small / (L) Mirror - Scratch - Small / (L) Front Fender, Molding - Scratch - Small / Front Bumper, Grille, Lamps - Scratch &amp; Dent - Medium / Bonnet, Headlight - Scratch - Medium / Roof - Scratch - Small</p>
