## General Information

<b>Make</b>	Toyota	<b>Model</b>	Wigo
<b>YOM</b>	2020	<b>Odo Meter Reading</b>	69,393
<b>Registration No.</b>	NGA5403	<b>Chassis No.</b>	MHKAADP5FLJ043871
<b>CC</b>	1.0	<b>Transmission</b>	A/T
<b>Fuel Type</b>	Gas	<b>Type of Body</b>	Hatchback
<b>Colour</b>	Gray

## Body / Panel Condition

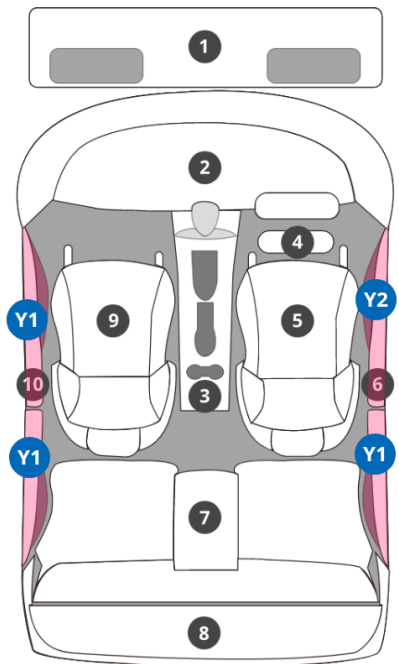
<b>Interior Evaluation :</b> <span style="color: red; font-weight: bold; font-size: 1.2em;">A</span>	<b>Exterior Evaluation :</b> <span style="color: red; font-weight: bold; font-size: 1.2em;">C</span>

<p><b>a</b> : Cut, Fray <b>d</b> : Loose, Deformed <b>k</b> : Animal Hair <b>s</b> : Smell <b>t</b> : Cigarette Burns <b>x</b> : Defective <b>y</b> : Stain</p>

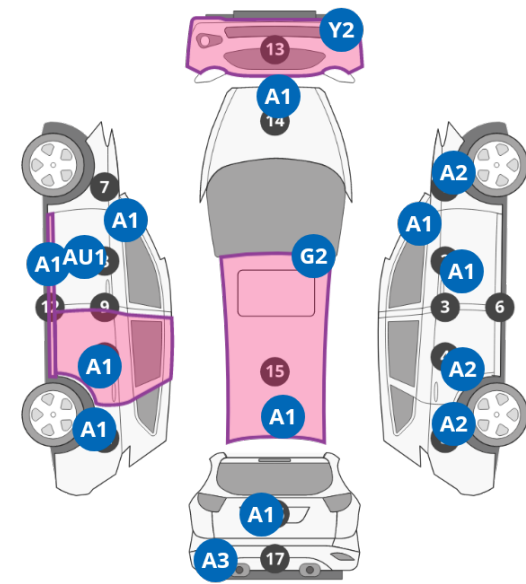
<p><b>A</b> : Scratch <b>AU</b> : Scratch &amp; Dent <b>B</b> : Modified <b>C</b> : Corrosion <b>G</b> : Stone chip <b>P</b> : Faded <b>S</b> : Rust <b>SC</b> : Rust &amp; Corrosion <b>U</b> : Dent <b>X</b> : Defective <b>Y</b> : Crack, Gap</p>
<p><b>Remarks</b> (L) Rear Trim - Grime - Minimal / (L) Front Trim - Grime - Minimal / (R) Rear Trim - Grime - Minimal / (R) Front Trim - Grime - Small</p>	<p><b>Remarks</b> (R) Front Fender - Repair Traces - Yes / (L) Front Fender - Repair Traces - Yes / (L) Front Door - Repair Traces - Yes / (L) Step - Repair Traces - Yes / (L) Rear Door - Repair Traces - Yes / (L) Rear Fender - Repair Traces - Yes / Trunk Hood, Rear Gate - Repair Traces - Yes / Roof - Repair Traces - Yes / (R) Front Fender, Molding - Scratch - Small / (R) Mirror - Scratch - Minimal / Overall Exterior - Full Re-Paint in same color - Yes / (R) Front Door, Molding - Scratch - Minimal / (R) Rear Door, Molding - Scratch - Small / Front Windshield - Scratch, Stone chip - Small / (R) Rear Fender, Molding - Scratch - Small / Rear Bumper, Lamps, Panels - Scratch - Medium / Roof Spoiler, Molding - Scratch - Minimal / Trunk Hood, Rear Gate - Scratch - Minimal / (L) Rear Fender, Molding - Scratch - Minimal / (L) Rear Door, Molding - Repair mark - Yes / (L) Rear Door, Molding - Scratch - Minimal / (L) Step, In-panel, Side Spoiler - Repair mark - Yes / (L) Step, In-panel, Side Spoiler - Scratch - Minimal / (L) Front Door, Molding - Scratch &amp; Dent - Minimal / (L) Mirror - Scratch - Minimal / Front Bumper, Grille, Lamps - Repair mark - Yes / Front Bumper, Grille, Lamps - Crack, Gap - Small / Bonnet, Headlight - Scratch - Minimal / Roof - Repair mark - Yes</p>
