General Information

Make	Suzuki	Model	Carry
YOM	2025	Odo Meter Reading	26,030
Registration No.	FAT5419	Chassis No.	MHYDC61TOTJ270960
CC	1.5	Transmission	M/T
Fuel Type	Gas	Type of Body	Van
Colour	White

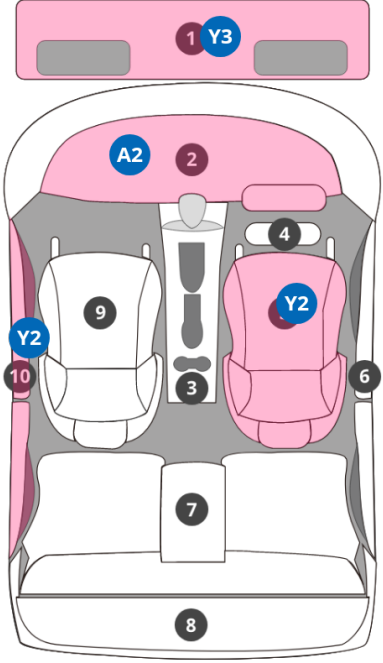
Interior Evaluation : B	Exterior Evaluation : B

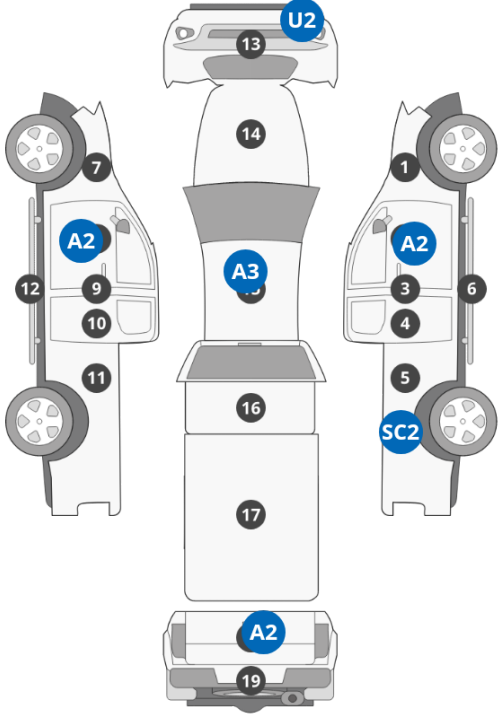
<p>A : Scratch AU : Scratch & Dent B : Modified C : Corrosion G : Stone chip P : Faded S : Rust SC : Rust & Corrosion U : Dent X : Defective Y : Crack, Gap</p>
<p>Remarks Ceiling - Grime - Medium / Dashboard - Worn, Scratch, Cut, Crack - Small / (R) Front Seat - Grime - Small / (L) Front Trim - Grime - Small</p>	<p>Remarks (R) Front Door - Repair Traces - Yes / Front Panel - Repair Traces - Yes / (L) Front Door - Repair Traces - Yes / (L) Rear Corner Panel - Repair Traces - Yes / (R) Rear Corner Panel - Repair Traces - Yes / Roof - Scratch - Medium / (R) Rear Door, Molding - Scratch - Small / (R) Side Gate - Rust, Corrosion - Small / Rear Gate - Scratch - Small / (L) Front Door, Molding - Scratch - Small / Front Bumper, Grille, Lamps - Dent - Small</p>
