General Information

| Make | Toyota | Model | Vios |
| Registration No. | HAH5956 | Chassis No. | PA1B18F38R4262848 |

Overall Evaluation :

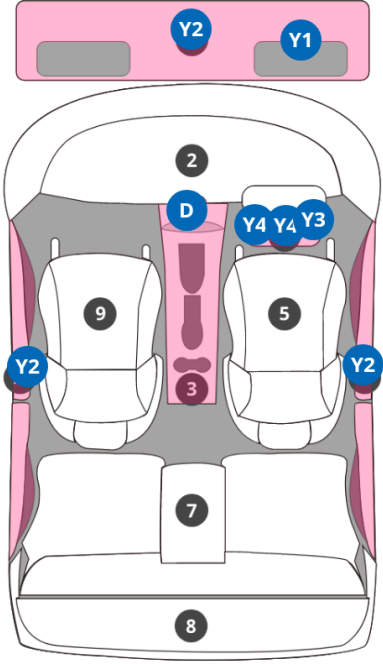
| Interior Evaluation : C | Exterior Evaluation : E |

| <p>Remarks (L) Front Trim - Grime - Small / (L) Front Floor Mat - Grime - Large / Sunvisor, Sunglass Holder - Grime - Minimal / Ceiling - Grime - Small / Mat Other - Grime - Large / (R) Front Trim - Grime - Small / (R) Front Floor Mat - Grime - Medium / Console, Switches, Vents - Traces of Adhesive Tape - Yes</p> | <p>Remarks (L) Front Fender, Molding - Scratch & Dent - Medium / (L) Mirror - Scratch - Minimal / (L) Front Door, Molding - Scratch - Minimal / (L) Step, In-panel, Side Spoiler - Scratch - Minimal / (L) Rear Fender, Molding - Scratch & Dent - Large / (L) Rear Door, Molding - Scratch - Small / Trunk Hood, Rear Gate - Scratch - Small / Rear Bumper, Lamps, Panels - Scratch - Large / (R) Rear Fender, Molding - Scratch & Dent - Medium / (R) Rear Door, Molding - Scratch & Dent - Large / (R) Front Door, Molding - Scratch & Dent - Small / (R) Mirror - Scratch - Small / (R) Front Fender, Molding - Scratch - Minimal / Bonnet, Headlight - Scratch - Large / Front Bumper, Grille, Lamps - Scratch & Dent - Large</p> |
