## General Information

<b>Make</b>	Toyota	<b>Model</b>	Wigo
<b>YOM</b>	2024	<b>Odo Meter Reading</b>	13,059
<b>Registration No.</b>	DBM6489	<b>Chassis No.</b>	MHKAA1BC4RJ015211
<b>CC</b>	1.0	<b>Transmission</b>	CVT
<b>Fuel Type</b>	Gas	<b>Type of Body</b>	Hatchback
<b>Colour</b>	Orange

## Body / Panel Condition

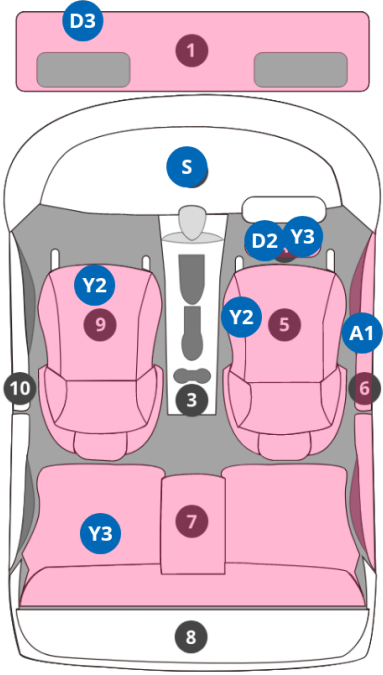
<b>Interior Evaluation :</b> <span style="float: right; color: red; font-weight: bold;">C</span>	<b>Exterior Evaluation :</b> <span style="float: right; color: red; font-weight: bold;">E</span>

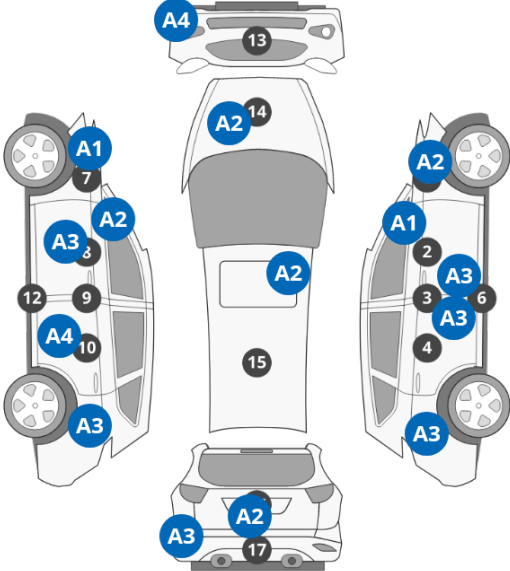
<p><b>A</b> : Scratch <b>AU</b> : Scratch &amp; Dent <b>B</b> : Modified <b>C</b> : Corrosion <b>G</b> : Stone chip <b>P</b> : Faded <b>S</b> : Rust <b>SC</b> : Rust &amp; Corrosion <b>U</b> : Dent <b>X</b> : Defective <b>Y</b> : Crack, Gap</p>
<p><b>Remarks</b> (L) Front Floor Mat - Worked - Small / (R) Front Floor Mat - Grime - Medium / (R) Front Seat - Grime - Small / (L) Front Seat - Grime - Small / Rear Seat - Grime - Medium / Ceiling - Crinkle - Medium / Overall Interior - Smell - Yes / (R) Front Trim - Cut, Crack - Minimal</p>	<p><b>Remarks</b> (R) Front Fender, Molding - Scratch - Small / (R) Mirror - Scratch - Minimal / (R) Front Door, Molding - Scratch - Medium / (R) Rear Door, Molding - Scratch - Medium / (R) Rear Fender, Molding - Scratch - Medium / Rear Bumper, Lamps, Panels - Scratch - Medium / Trunk Hood, Rear Gate - Scratch - Small / (L) Rear Fender, Molding - Scratch - Medium / (L) Rear Door, Molding - Scratch - Large / (L) Front Door, Molding - Scratch - Medium / (L) Mirror - Scratch - Small / (L) Front Fender, Molding - Scratch - Minimal / Front Bumper, Grille, Lamps - Scratch - Large / Bonnet, Headlight - Scratch - Small / Roof - Scratch - Small</p>
