## General Information

<b>Make</b>	Toyota	<b>Model</b>	Vios
<b>YOM</b>	2025	<b>Odo Meter Reading</b>	17,411
<b>Registration No.</b>	GBF7711	<b>Chassis No.</b>	PA1B18F39R4276287
<b>CC</b>	1.3	<b>Transmission</b>	CVT
<b>Fuel Type</b>	Gas	<b>Type of Body</b>	Sedan
<b>Colour</b>	Silver

## Body / Panel Condition

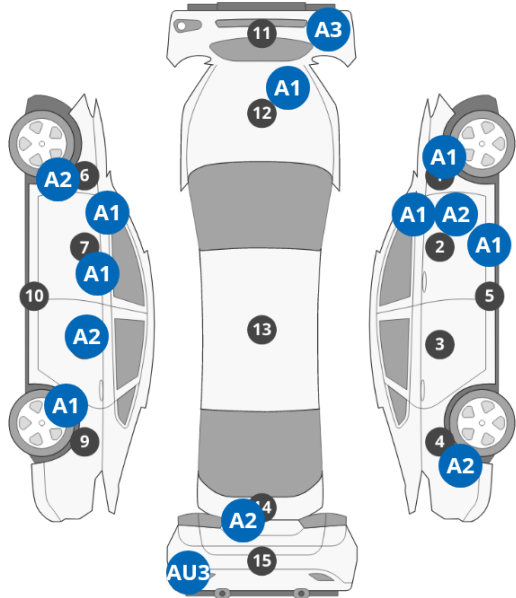
<p><b>A</b> : Scratch <b>AU</b> : Scratch &amp; Dent <b>B</b> : Modified <b>C</b> : Corrosion <b>G</b> : Stone chip <b>P</b> : Faded <b>S</b> : Rust <b>SC</b> : Rust &amp; Corrosion <b>U</b> : Dent <b>X</b> : Defective <b>Y</b> : Crack, Gap</p>
<p><b>Remarks</b> (R) Front Trim - Grime - Small / (R) Front Floor Mat - Worked - Small / Rear Seat - Grime - Large / (R) Rear Trim - Grime - Small / Mat Other - Grime - Small / (L) Front Trim - Grime - Small / (L) Front Floor Mat - Grime - Medium / Ceiling - Grime - Small</p>	<p><b>Remarks</b> (L) Front Fender, Molding - Scratch - Small / (L) Mirror - Scratch - Minimal / (L) Rear Door, Molding - Scratch - Small / (L) Front Door, Molding - Scratch - Minimal / (L) Rear Fender, Molding - Scratch - Minimal / Rear Bumper, Lamps, Panels - Scratch &amp; Dent - Medium / Trunk Hood, Rear Gate - Scratch - Small / (R) Rear Fender, Molding - Scratch - Small / (R) Front Door, Molding - Scratch - Small / (R) Front Fender, Molding - Scratch - Minimal / (R) Step, In-panel, Side Spoiler - Scratch - Minimal / (R) Mirror - Scratch - Minimal / Front Bumper, Grille, Lamps - Scratch - Medium / Bonnet, Headlight - Scratch - Minimal</p>
