## General Information

<b>Make</b>	Toyota	<b>Model</b>	Vios
<b>YOM</b>	2025	<b>Odo Meter Reading</b>	16,289
<b>Registration No.</b>	DBR8469	<b>Chassis No.</b>	PA1B18F33R4276527
<b>CC</b>	1.3	<b>Transmission</b>	CVT
<b>Fuel Type</b>	Gas	<b>Type of Body</b>	Sedan
<b>Colour</b>	Silver

## Body / Panel Condition

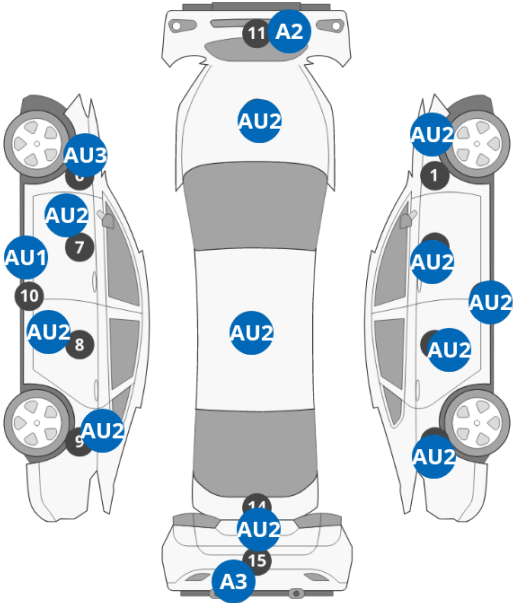
<p><b>A</b> : Scratch <b>AU</b> : Scratch &amp; Dent <b>B</b> : Modified <b>C</b> : Corrosion <b>G</b> : Stone chip <b>P</b> : Faded <b>S</b> : Rust <b>SC</b> : Rust &amp; Corrosion <b>U</b> : Dent <b>X</b> : Defective <b>Y</b> : Crack, Gap</p>
<p><b>Remarks</b> (R) Front Seat - Grime - Small / (L) Front Trim - Grime - Small / (R) Front Trim - Grime - Small / Rear Seat - Grime - Small / Ceiling - Grime - Small / (L) Front Floor Mat - Grime - Medium / (L) Front Seat - Grime - Medium</p>	<p><b>Remarks</b> Roof - Scratch &amp; Dent - Small / (L) Rear Door, Molding - Scratch &amp; Dent - Small / (L) Rear Fender, Molding - Scratch &amp; Dent - Small / Trunk Hood, Rear Gate - Scratch &amp; Dent - Small / Rear Bumper, Lamps, Panels - Scratch - Medium / (R) Rear Fender, Molding - Scratch &amp; Dent - Small / (R) Rear Door, Molding - Scratch &amp; Dent - Small / (R) Front Door, Molding - Scratch &amp; Dent - Small / (R) Step, In-panel, Side Spoiler - Scratch &amp; Dent - Small / (R) Front Fender, Molding - Scratch &amp; Dent - Small / Bonnet, Headlight - Scratch &amp; Dent - Small / (L) Front Fender, Molding - Scratch &amp; Dent - Medium / (L) Front Door, Molding - Scratch &amp; Dent - Small / Front Bumper, Grille, Lamps - Scratch - Small / (L) Step, In-panel, Side Spoiler - Scratch &amp; Dent - Minimal</p>
