## General Information

<b>Make</b>	Toyota	<b>Model</b>	Vios
<b>YOM</b>	2025	<b>Odo Meter Reading</b>	21,507
<b>Registration No.</b>	HAH5889	<b>Chassis No.</b>	PA1B18F35R4279638
<b>CC</b>	1.3	<b>Transmission</b>	CVT
<b>Fuel Type</b>	Gas	<b>Type of Body</b>	Sedan
<b>Colour</b>	Red Mica Metallic

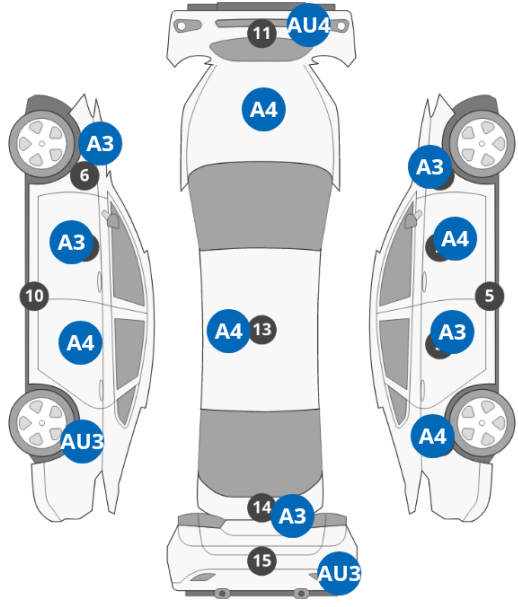
<p><b>A</b> : Scratch <b>AU</b> : Scratch &amp; Dent <b>B</b> : Modified <b>C</b> : Corrosion <b>G</b> : Stone chip <b>P</b> : Faded <b>S</b> : Rust <b>SC</b> : Rust &amp; Corrosion <b>U</b> : Dent <b>X</b> : Defective <b>Y</b> : Crack, Gap</p>
<p><b>Remarks</b> (L) Front Trim - Grime - Small / (L) Front Floor Mat - Grime - Small / Sunvisor, Sunglass Holder - Grime - Minimal / Ceiling - Grime - Minimal / Console, Switches, Vents - Traces of Adhesive Tape - Yes / Mat Other - Missing - Yes / (R) Front Floor Mat - Missing - Yes / (R) Front Trim - Grime - Small</p>	<p><b>Remarks</b> (L) Front Fender, Molding - Scratch - Medium / (L) Front Door, Molding - Scratch - Medium / (L) Rear Door, Molding - Scratch - Large / (L) Rear Fender, Molding - Scratch &amp; Dent - Medium / Trunk Hood, Rear Gate - Scratch - Medium / Rear Bumper, Lamps, Panels - Scratch &amp; Dent - Medium / (R) Rear Fender, Molding - Scratch - Large / (R) Rear Door, Molding - Scratch - Medium / (R) Front Door, Molding - Scratch - Large / (R) Front Fender, Molding - Scratch - Medium / Bonnet, Headlight - Scratch - Large / Front Bumper, Grille, Lamps - Scratch &amp; Dent - Large / Roof - Scratch - Large</p>
