General Information

Make	Toyota	Model	Avanza
YOM	2025	Odo Meter Reading	19,048
Registration No.	GBK7641	Chassis No.	MHFAA1BY3S0044303
CC	1.3	Transmission	CVT
Fuel Type	Gas	Type of Body	MPV
Colour	Black

Body / Panel Condition

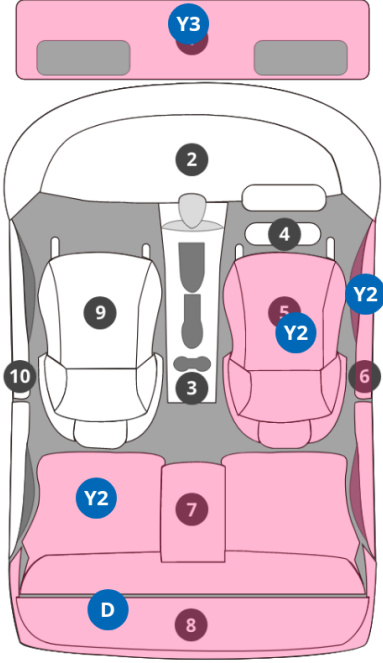
Interior Evaluation : B	Exterior Evaluation : D

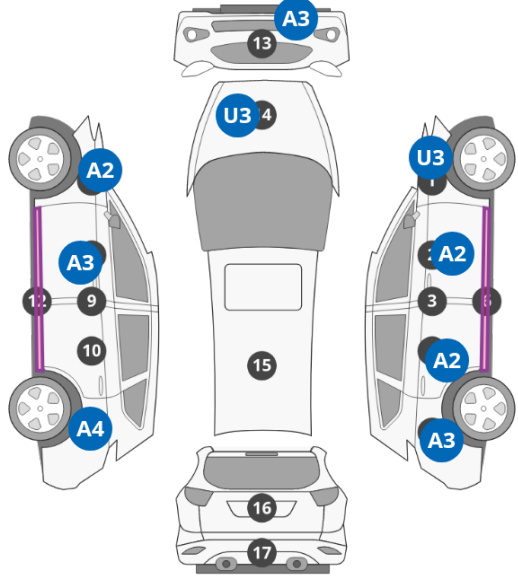
<p>A : Scratch AU : Scratch & Dent B : Modified C : Corrosion G : Stone chip P : Faded S : Rust SC : Rust & Corrosion U : Dent X : Defective Y : Crack, Gap</p>
<p>Remarks Ceiling - Grime - Medium / Trunk Room - Repair Mark - Yes / (R) Front Trim - Grime - Small / Rear Seat - Grime - Small / (R) Front Seat - Grime - Small</p>	<p>Remarks (R) Front Door - Repair Traces - Yes / (R) Step - Replaced - Yes / (R) Step - Repair Traces - Yes / Bonnet - Repair Traces - Yes / (L) Front Door - Repair Traces - Yes / (L) Step - Replaced - Yes / Trunk Hood, Rear Gate - Repair Traces - Yes / (R) Front Fender, Molding - Dent - Medium / Bonnet, Headlight - Dent - Medium / (L) Front Fender, Molding - Scratch - Small / (L) Rear Door, Molding - Scratch - Medium / (L) Rear Fender, Molding - Scratch - Large / (R) Rear Fender, Molding - Scratch - Medium / (R) Rear Door, Molding - Scratch - Small / (R) Front Door, Molding - Scratch - Small / Front Bumper, Grille, Lamps - Scratch - Medium</p>
