## General Information

Date & Time: 24, Feb, 2026 17:00

<b>Make</b>	Toyota	<b>Model</b>	Vios
<b>YOM</b>	2023	<b>Odo Meter Reading</b>	49,043
<b>Registration No.</b>	GBG4033	<b>Chassis No.</b>	PA1B18F36P4218845
<b>CC</b>	1.3	<b>Transmission</b>	CVT
<b>Fuel Type</b>	Gas	<b>Type of Body</b>	Sedan
<b>Colour</b>	Red Mica Metallic

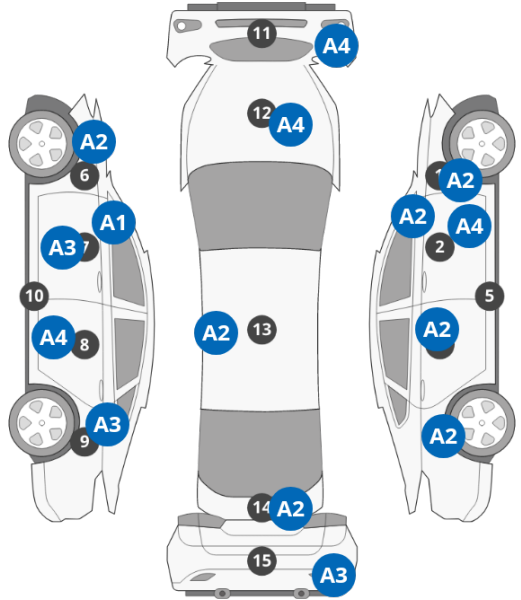
<p><b>A</b> : Scratch <b>AU</b> : Scratch &amp; Dent <b>B</b> : Modified <b>C</b> : Corrosion <b>G</b> : Stone chip <b>P</b> : Faded <b>S</b> : Rust <b>SC</b> : Rust &amp; Corrosion <b>U</b> : Dent <b>X</b> : Defective <b>Y</b> : Crack, Gap</p>
<p><b>Remarks</b> (L) Front Trim - Grime - Medium / (L) Front Floor Mat - Cut, Crack - Medium / Ceiling - Grime - Small / Rear Seat - Grime - Large / Mat Other - Grime - Large / (R) Front Trim - Grime - Medium / (R) Front Floor Mat - Grime - Medium</p>	<p><b>Remarks</b> (L) Front Fender, Molding - Scratch - Small / (L) Mirror - Scratch - Minimal / (L) Front Door, Molding - Scratch - Medium / (L) Rear Door, Molding - Scratch - Large / (L) Rear Fender, Molding - Scratch - Medium / Trunk Hood, Rear Gate - Scratch - Small / Rear Bumper, Lamps, Panels - Scratch - Medium / (R) Rear Fender, Molding - Scratch - Small / (R) Rear Door, Molding - Scratch - Small / (R) Mirror - Scratch - Small / (R) Front Door, Molding - Scratch - Large / (R) Front Fender, Molding - Scratch - Small / Bonnet, Headlight - Scratch - Large / Front Bumper, Grille, Lamps - Scratch - Large / Roof - Scratch - Small</p>
